Contract #: 04-0120F4Cty: SF/ALA Rte: 80 PM: 13.2/13.9File #: 69.28**WELDING INSPECTION REPORT****Resident Engineer:** Pursell, Gary**Address:** 333 Burma Road**City:** Oakland, CA 94607**Report No:** WIR-007573**Date Inspected:** 16-Jun-2009**Project Name:** SAS Superstructure**OSM Arrival Time:** 700**Prime Contractor:** American Bridge/Fluor Enterprises, a JV**OSM Departure Time:** 1900**Contractor:** Zhenhua Port Machinery Company, Ltd (ZPMC), Changxing Island **Location:** Shanghai, China**CWI Name:** Wu Zhi Cheng**CWI Present:** Yes No**Inspected CWI report:** Yes No N/A**Rod Oven in Use:** Yes No N/A**Electrode to specification:** Yes No N/A**Weld Procedures Followed:** Yes No N/A**Qualified Welders:** Yes No N/A**Verified Joint Fit-up:** Yes No N/A**Approved Drawings:** Yes No N/A**Approved WPS:** Yes No N/A**Delayed / Cancelled:** Yes No N/A**Bridge No:** 34-0006**Component:** OBG Segments**Summary of Items Observed:**

# WELDING INSPECTION REPORT

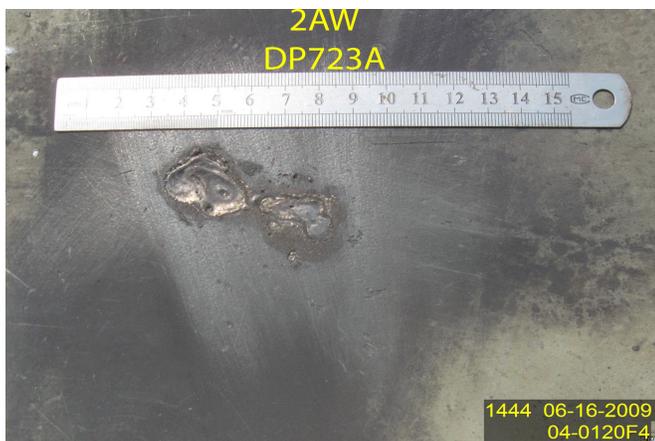
This QA Inspector observed base metal damage approximately 50mm in length and 1mm in depth at location of removed temporary fit up bracket on DP732A.
