**DEPARTMENT OF TRANSPORTATION**

Contract #: 04-0120F4Cty: SF/ALA Rte: 80 PM: 13.2/13.9File #: 69.28**WELDING INSPECTION REPORT****Resident Engineer:** Pursell, Gary**Address:** 333 Burma Road**City:** Oakland, CA 94607**Report No:** WIR-007629**Date Inspected:** 25-Jun-2009**Project Name:** SAS Superstructure**OSM Arrival Time:** 1900**Prime Contractor:** American Bridge/Fluor Enterprises, a JV**OSM Departure Time:** 700**Contractor:** Zhenhua Port Machinery Company, Ltd (ZPMC), Changxing Island **Location:** Shanghai, China**CWI Name:** See Below**CWI Present:** Yes No**Inspected CWI report:** Yes No N/A**Rod Oven in Use:** Yes No N/A**Electrode to specification:** Yes No N/A**Weld Procedures Followed:** Yes No N/A**Qualified Welders:** Yes No N/A**Verified Joint Fit-up:** Yes No N/A**Approved Drawings:** Yes No N/A**Approved WPS:** Yes No N/A**Delayed / Cancelled:** Yes No N/A**Bridge No:** 34-0006**Component:** OBG and Tower Fabrication**Summary of Items Observed:**

## WELDING INSPECTION REPORT

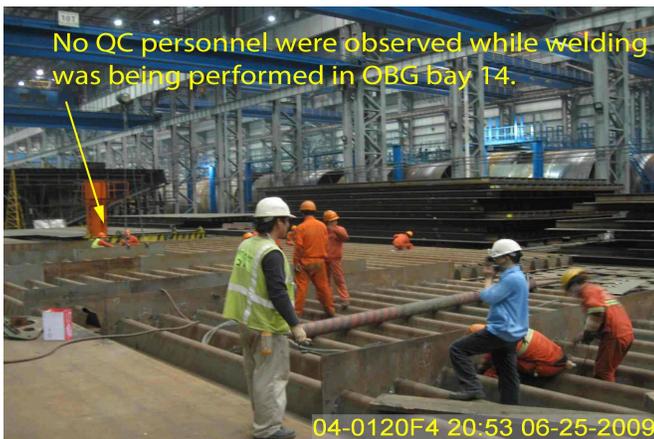
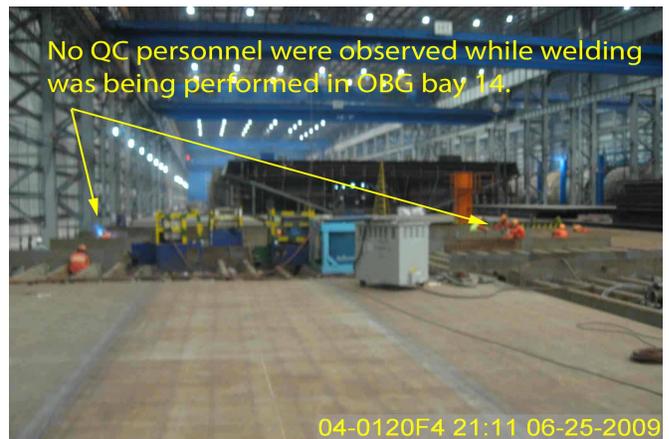
This QA Inspector observed ZPMC welder Mr. Xue Yian, stencil 040634 using submerged arc welding procedure specification WPS-B-T-4221-BU3-C-S-1 to make groove weld SD1-A6002-3-3B. This QA Inspector observed CWI Mr. Zhan Bo monitoring the base material temperature with a 110 degree Celsius temperature indicating crayon and QC personnel were monitoring other welding attributes. This QA Inspector observed CWI Mr. Zhan Bo measured a welding current of approximately 640 amps and 29.0 volts. This QA Inspector measured a welding travel speed of 460 mm per minute. Items observed by this QA Inspector appear to be progressing in compliance with project specifications.

This QA Inspector observed ZPMC welder Ms. Dong Jun Feng, stencil 202756 using submerged arc welding procedure specification WPS-B-T-4221-BU3-C-S-1 to make groove weld SD1-A6002-7-4B. This QA Inspector observed CWI Mr. Zhan Bo monitoring the base material temperature with a 110 degree Celsius temperature indicating crayon and QC personnel were monitoring other welding attributes. This QA Inspector observed CWI Mr. Zhan Bo measured a welding current of approximately 610 amps and 30.5 volts and a welding travel speed of 420 mm per minute. Items observed by this QA Inspector appear to be progressing in compliance with project specifications.
