Contract #: 04-0120F4Cty: SF/ALA Rte: 80 PM: 13.2/13.9File #: 13.28**WELDING INSPECTION REPORT****Resident Engineer:** Pursell, Gary**Address:** 333 Burma Road**City:** Oakland, CA 94607**Report No:** WIR-007875**Date Inspected:** 17-Jul-2009**Project Name:** SAS Superstructure**OSM Arrival Time:** 1400**Prime Contractor:** American Bridge/Fluor Enterprises, a JV**OSM Departure Time:** 2230**Contractor:** Oregon Iron Works Clackamas, Or.**Location:** Clackamas, OR

**Bridge No:** 34-0006**Component:** Hinge-K Components**Summary of Items Observed:**

Summary of Items Observed: On this date, Caltrans Quality Assurance Inspector (QA) Clete Henke was present at Oregon Iron Works, Inc. (OIW) in Clackamas, OR for observation of fabrication of the Hinge K Pipe Beams and related activities including in process welding and OIW Quality Control (QC) visual and nondestructive testing. The following observations were recorded:

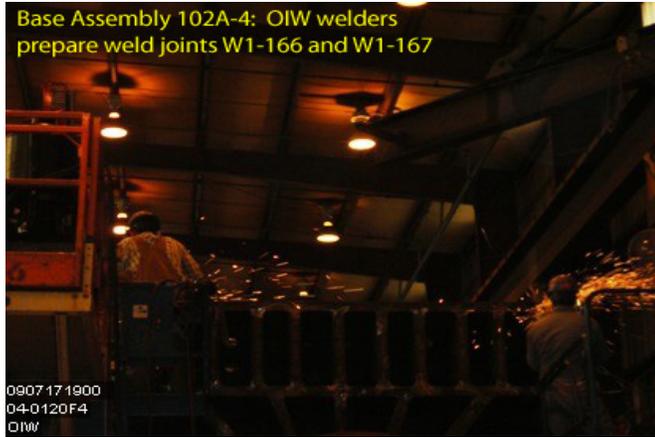
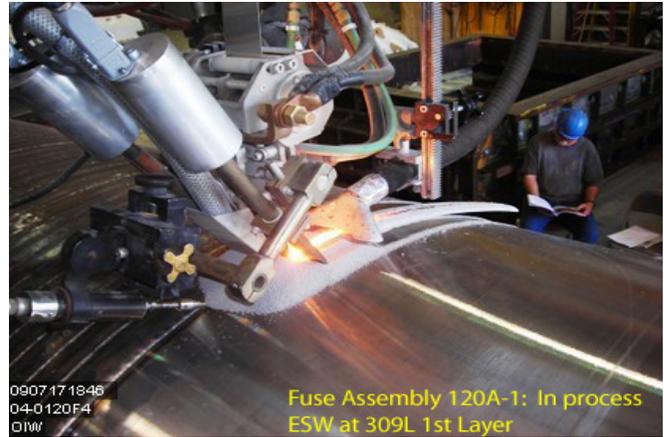
during in progress Submerged Arc Welding (SAW) at weld joints W1-166 & W1-167 respectively. The referenced connections join a106 & ab106 stiffeners and b106 stiffener. The QA Inspector observed as OIW QC Inspector Steve Barnett performed Magnetic particle Testing (MT) and Visual Inspection (VT) of completed root passes at weld joints W1-166 and W1-167. Mr. Barnett stated that he had located no rejectable indications. The QA Inspector subsequently performed 100% VT & 50% MT verification at the locations noted above finding the root passes to be in general compliance with contract documents. Please reference TL-6028 report for this date for details. The QA Inspector intermittently observed as welders B10 & B28 continued to deposit SAW fill and cover passes in the horizontal (2F) position in accordance with approved welding procedure 4020. The QA Inspector noted the OIW welders were maintaining continuous preheat utilizing a torch. The referenced connections were completed during the shift. The QA Inspector observed OIW QC Inspector Barnett regularly monitoring and recording the in process SAW parameters. The QA Inspector also intermittently observed in process welding parameters and determined that the SAW parameters and minimum preheat/interpass temperature appeared to be in general compliance with the contract requirements -- (W1-166: 35 volts, 585 amperes, 432mm/min travel speed).

The QA Inspector intermittently observed OIW qualified welder Vincent Vu (WID V7) during in-process welding of Soudotape 309L stainless steel overlay to hinge k pipe beam fuse sub-assembly 120A-1. The weld joint is identified as 309L 1st layer. Mr. Vu was observed welding in the flat position utilizing automatic electro slag welding (ESW) overlay process with a .5mm x 60mm Soudotape 309L stainless electrode, filler metal brand Soudotape class EQ309L automatic. An OIW helper was observed assisting welder V7 during ESW activity. The QA Inspector observed OIW QC Inspector Steve Barnett regularly monitoring and recording the in process ESW parameters. The QA Inspector also intermittently observed in process welding parameters and determined that the ESW parameters (1200 amps, 26 volts, 229mm/min travel speed) and minimum preheat temperature of 225° F appeared to be in general compliance with the contract requirements and approved OIW Welding Procedure Specification (WPS) 7003.
