DEPARTMENT OF TRANSPORTATION

Quality Assurance and Source Inspection

Contract #: 04-0120F4Cty: SF/ALA Rte: 80 PM: 13.2/13.9File #: 69.28**WELDING INSPECTION REPORT****Resident Engineer:** Pursell, Gary**Address:** 333 Burma Road**City:** Oakland, CA 94607**Report No:** WIR-007937**Date Inspected:** 28-Jul-2009**Project Name:** SAS Superstructure**OSM Arrival Time:** 1900**Prime Contractor:** American Bridge/Fluor Enterprises, a JV**OSM Departure Time:** 700**Contractor:** Zhenhua Port Machinery Company, Ltd (ZPMC), Changxing Island **Location:** Shanghai, China**CWI Name:** Li Jia**CWI Present:** Yes No**Inspected CWI report:** Yes No N/A**Rod Oven in Use:** Yes No N/A**Electrode to specification:** Yes No N/A**Weld Procedures Followed:** Yes No N/A**Qualified Welders:** Yes No N/A**Verified Joint Fit-up:** Yes No N/A**Approved Drawings:** Yes No N/A**Approved WPS:** Yes No N/A**Delayed / Cancelled:** Yes No N/A**Bridge No:** 34-0006**Component:** OBG trial assembly/OBG bays 13, 14 and 19**Summary of Items Observed:**

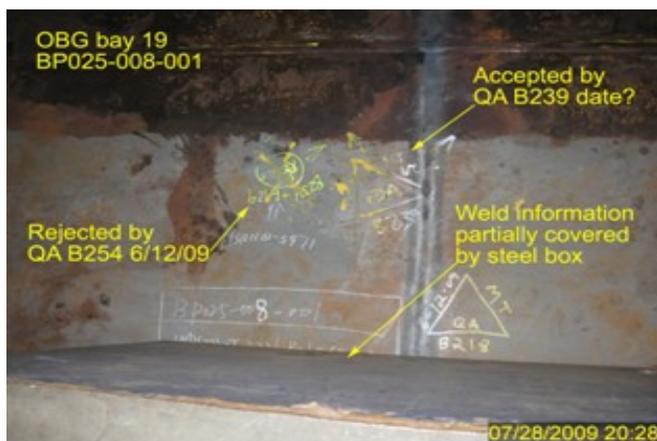
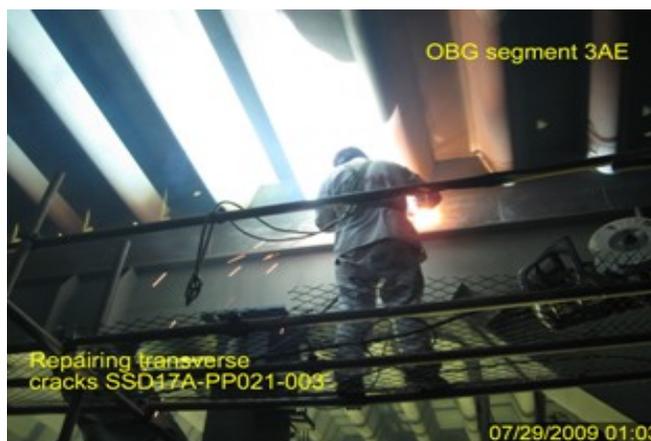
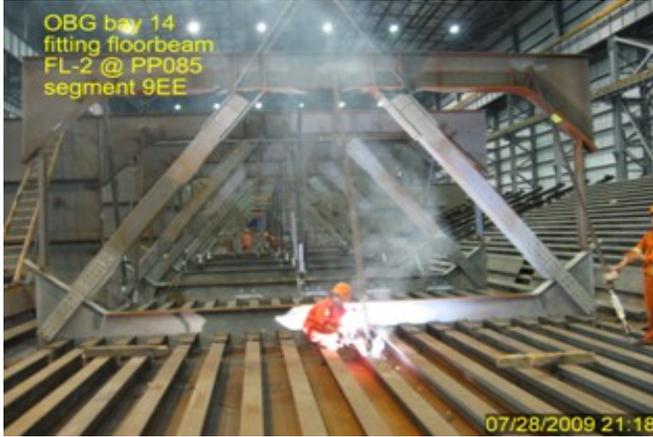
This QA observed ZPMC qualified welding personnel identified as 051356 and 044795 perform FCAW repair welding of what appeared to be delayed transverse cracks discovered via Magnetic particle Testing (MT) on weld joint identified as SSD17A-PP021-003. ZPMC QC identified as Mr. Zhang Hai Tao was present to monitor the welding process. The welding parameters as measured using QC's calibrated instruments appeared to be in general compliance with WPS-345-FCAW-2G-repair-2.

This QA observed ZPMC personnel fitting and tack welding FL-2 floorbeam to OBG segment identified as 9EE at panel point PP085. No other significant work was observed in this bay during the time QA was present.
