DEPARTMENT OF TRANSPORTATION

Quality Assurance and Source Inspection

Contract #: 04-0120F4Cty: SF/ALA Rte: 80 PM: 13.2/13.9File #: 13.28**WELDING INSPECTION REPORT****Resident Engineer:** Pursell, Gary**Address:** 333 Burma Road**City:** Oakland, CA 94607**Report No:** WIR-008524**Date Inspected:** 18-Aug-2009**Project Name:** SAS Superstructure**OSM Arrival Time:** 700**Prime Contractor:** American Bridge/Fluor Enterprises, a JV**OSM Departure Time:** 1530**Contractor:** Oregon Iron Works Clackamas, Or.**Location:** Clackamas, OR**CWI Name:** Mike Gregson, Jose Salazar**CWI Present:** Yes No**Inspected CWI report:** Yes No N/A**Rod Oven in Use:** Yes No N/A**Electrode to specification:** Yes No N/A**Weld Procedures Followed:** Yes No N/A**Qualified Welders:** Yes No N/A**Verified Joint Fit-up:** Yes No N/A**Approved Drawings:** Yes No N/A**Approved WPS:** Yes No N/A**Delayed / Cancelled:** Yes No N/A**Bridge No:** 34-0006**Component:** Hinge K Pipe Beams**Summary of Items Observed:**

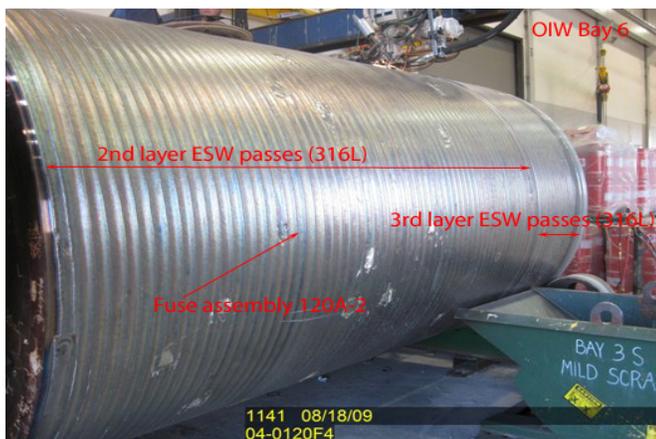
Hinge-K Pipe Beam Fuse Assembly 120A-2: 8/18/09

a124-3 Half Fuse to a124-11 Half Fuse

QA Inspector noticed that the ESW stainless steel overlay passes were in-process, on this fuse assembly 120A-2. QA Inspector witnessed welder #F17, Mr. Igor Frolov performing electro slag welding (ESW) on the third and final layer welding passes, (approximately 10% complete), in the flat position, utilizing Soudokay brand Soudotape 316L stainless steel consumable strip. QA Inspector noted the first layer passes were previously completed utilizing the 309L consumable strip and second layers utilizing the 316L consumable strip, per contract requirements. QA Inspector randomly noticed QC Inspector's Mike Gregson and Jose Salazar were present, to verify in-process welding parameters (amps/volts) and monitor in-process continuous pre-heat temperatures. QA Inspector spoke with QC Inspector Jose Salazar and Mr. Salazar explained that welding amps were recorded as 1200 amps/25.3 volts, travel speed at 241mm/min. and a pre-heat temperature recorded at 70 degrees Fahrenheit (20 C). QA Inspector verified Mr. Igor Frolov was currently qualified for this welding process/position and randomly recorded pre-heat temperatures of approximately 70 degrees Fahrenheit. QA Inspector noted that Mr. Igor Frolov appeared to be in compliance with the applicable approved welding procedure specification (WPS 7003). See attached picture below.
