**DEPARTMENT OF TRANSPORTATION**

Contract #: 04-0120F4Cty: SF/ALA Rte: 80 PM: 13.2/13.9File #: 69.28**WELDING INSPECTION REPORT****Resident Engineer:** Pursell, Gary**Address:** 333 Burma Road**City:** Oakland, CA 94607**Report No:** WIR-008530**Date Inspected:** 16-Aug-2009**Project Name:** SAS Superstructure**OSM Arrival Time:** 1900**Prime Contractor:** American Bridge/Fluor Enterprises, a JV**OSM Departure Time:** 700**Contractor:** Zhenhua Port Machinery Company, Ltd (ZPMC), Changxing Island **Location:** Shanghai, China

**Bay# 10- Tower Assembly:**

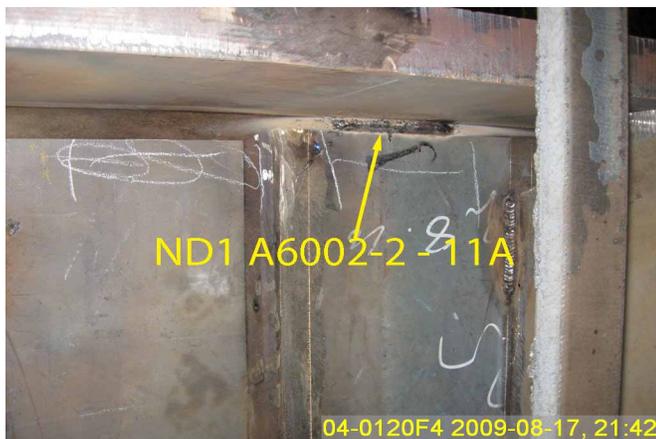
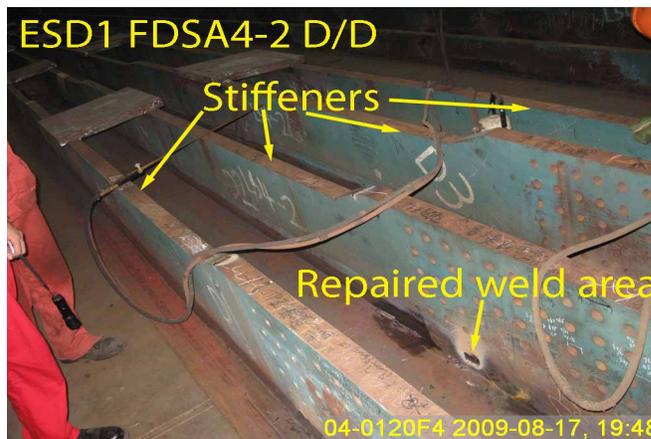
Weld buttering of Skin "A", west shaft lift#1 as per Weld Repair Report (WRR)# T-WR-1961 dated 08.16.09. Welder is identified as 068923. ZPMC QC is identified as Li Lin. The welding variables recorded by QC appeared to comply with the specified WPS no. WPS-345-FCAW-2(G) 2F Repair.

Non critical repair welding of skin plate & stiffeners located on PCMK ESD1 FDSA4-2 D/D. Welder is identified as 040675. ZPMC QC is identified as Xu Jin Long. The welding variables recorded by QC appeared to comply with the specified WPS no. WPS-345-SMAW-2G 2(F)-Repair.
