Contract #: 04-0120F4Cty: SF/ALA Rte: 80 PM: 13.2/13.9File #: 13.28**WELDING INSPECTION REPORT****Resident Engineer:** Pursell, Gary**Address:** 333 Burma Road**City:** Oakland, CA 94607**Report No:** WIR-008626**Date Inspected:** 18-Aug-2009**Project Name:** SAS Superstructure**OSM Arrival Time:** 1400**Prime Contractor:** American Bridge/Fluor Enterprises, a JV**OSM Departure Time:** 2230**Contractor:** Oregon Iron Works Clackamas, Or.**Location:** Clackamas, OR**CWI Name:** Steve Barnett, William Buck**CWI Present:** Yes No**Inspected CWI report:** Yes No N/A**Rod Oven in Use:** Yes No N/A**Electrode to specification:** Yes No N/A**Weld Procedures Followed:** Yes No N/A**Qualified Welders:** Yes No N/A**Verified Joint Fit-up:** Yes No N/A**Approved Drawings:** Yes No N/A**Approved WPS:** Yes No N/A**Delayed / Cancelled:** Yes No N/A**Bridge No:** 34-0006**Component:** Hinge-K Components**Summary of Items Observed:**

Summary of Items Observed: On this date, Caltrans Quality Assurance Inspector (QA) Clete Henke was present at Oregon Iron Works, Inc. (OIW) in Clackamas, OR for observation of fabrication of the Hinge K Pipe Beams and related activities including in process welding

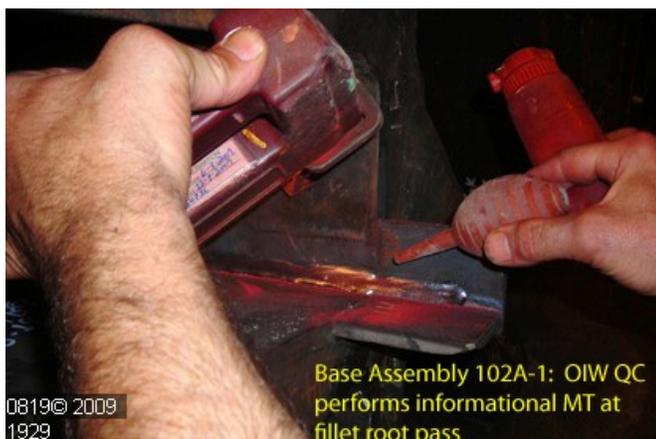
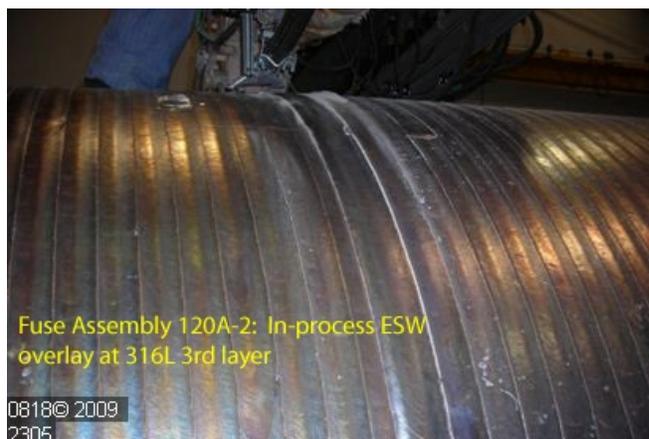
The QA Inspector intermittently monitored OIW welder Phuong Huynh (WID H4) during in progress Submerged Arc Welding (SAW) at weld joints W1-43, W1-47, W1-51, W1-55, W1-59, W1-63, W1-67 and W1-70 joining c106 stiffeners to a106 stiffener. OIW welder Vincent Vu (WID V7) was also observed during in-process SAW at weld joints W1-16, W1-20, W1-24, W1-28 and W1-32 joining c106 stiffeners to a107 stiffener. The QA Inspector randomly observed as OIW QC Inspector Bill Buck performed Magnetic particle Testing (MT) and Visual Inspection (VT) of completed root pass at weld joints referenced above. Mr. Buck performed informational MT at root pass of these fillet joints at the behest of OIW QC management. Mr. Buck stated that he had located no rejectable indications. The QA Inspector intermittently observed as welders H4 & V7 continued to deposit SAW fill and cover passes in the horizontal (2G) position in accordance with approved welding procedures 4020 rev. 2. The QA Inspector noted the OIW welders were maintaining continuous preheat utilizing a torch. OIW QC Inspector Bill Buck was observed regularly monitoring and recording the in process SAW parameters. The QA Inspector also intermittently observed in process welding parameters and determined that the SAW parameters and minimum preheat/interpass temperature appeared to be in general compliance with the contract requirements --

The QA Inspector intermittently observed OIW qualified welder Bounheune Savanh (WID S74) during in-process welding of Soudotape 316L stainless steel overlay to hinge k pipe beam fuse sub-assembly 120A-2. The weld joint is identified as 316L 3rd Layer. Mr. Savanh was observed welding in the flat position utilizing automatic electro slag welding (ESW) overlay process with a .5mm x 60mm Soudotape 316L stainless electrode, filler metal brand Soudotape class EQ316L automatic. An OIW helper was observed assisting welder S74 during ESW activity. The QA Inspector observed OIW QC Inspector Steve Barnett regularly monitoring and recording the in process ESW parameters. The QA Inspector also intermittently observed in process welding parameters and determined that the ESW parameters (1200 amps, 25.7 volts, 267mm/min travel speed) and minimum preheat temperature of 70° F appeared to be in general compliance with the contract requirements and approved OIW Welding Procedure Specification (WPS) 7003.
