DEPARTMENT OF TRANSPORTATION

Quality Assurance and Source Inspection

Contract #: 04-0120F4Cty: SF/ALA Rte: 80 PM: 13.2/13.9File #: 69.28**WELDING INSPECTION REPORT****Resident Engineer:** Pursell, Gary**Address:** 333 Burma Road**City:** Oakland, CA 94607**Report No:** WIR-008722**Date Inspected:** 20-Aug-2009**Project Name:** SAS Superstructure**OSM Arrival Time:** 1900**Prime Contractor:** American Bridge/Fluor Enterprises, a JV**OSM Departure Time:** 700**Contractor:** Zhenhua Port Machinery Company, Ltd (ZPMC), Changxing Island **Location:** Shanghai, China**CWI Name:** Li Yan Hua**CWI Present:** Yes No**Inspected CWI report:** Yes No N/A**Rod Oven in Use:** Yes No N/A**Electrode to specification:** Yes No N/A**Weld Procedures Followed:** Yes No N/A**Qualified Welders:** Yes No N/A**Verified Joint Fit-up:** Yes No N/A**Approved Drawings:** Yes No N/A**Approved WPS:** Yes No N/A**Delayed / Cancelled:** Yes No N/A**Bridge No:** 34-0006**Component:** OBG segments and tower skin E**Summary of Items Observed:**

WELDING INSPECTION REPORT

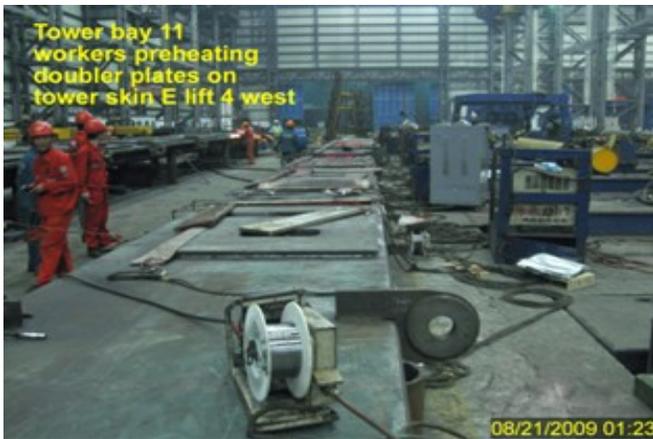
This QA observed ZPMC personnel preheating the doubler plates on west tower skin plate E for lift four, in preparation for welding. This QA noted that the preheating was being performed utilizing ceramic heating pads. ZPMC QC inspectors appeared to be monitoring the process in accordance with the contract documents.
