Contract #: 04-0120F4Cty: SF/ALA Rte: 80 PM: 13.2/13.9File #: 13.28**WELDING INSPECTION REPORT****Resident Engineer:** Pursell, Gary**Address:** 333 Burma Road**City:** Oakland, CA 94607**Report No:** WIR-008788**Date Inspected:** 03-Sep-2009**Project Name:** SAS Superstructure**OSM Arrival Time:** 1900**Prime Contractor:** American Bridge/Fluor Enterprises, a JV**OSM Departure Time:** 330**Contractor:** Oregon Iron Works Clackamas, Or.**Location:** Clackamas, OR**CWI Name:** Steve Barnett, Jon Nickolich**CWI Present:** Yes No**Inspected CWI report:** Yes No N/A**Rod Oven in Use:** Yes No N/A**Electrode to specification:** Yes No N/A**Weld Procedures Followed:** Yes No N/A**Qualified Welders:** Yes No N/A**Verified Joint Fit-up:** Yes No N/A**Approved Drawings:** Yes No N/A**Approved WPS:** Yes No N/A**Delayed / Cancelled:** Yes No N/A**Bridge No:** 34-0006**Component:** Hinge-K Components**Summary of Items Observed:**

Summary of Items Observed: On this date, Caltrans Quality Assurance Inspector (QA) Clete Henke was present at Oregon Iron Works, Inc. (OIW) in Clackamas, OR for observation of fabrication of the Hinge K Pipe Beams and related activities including in process welding

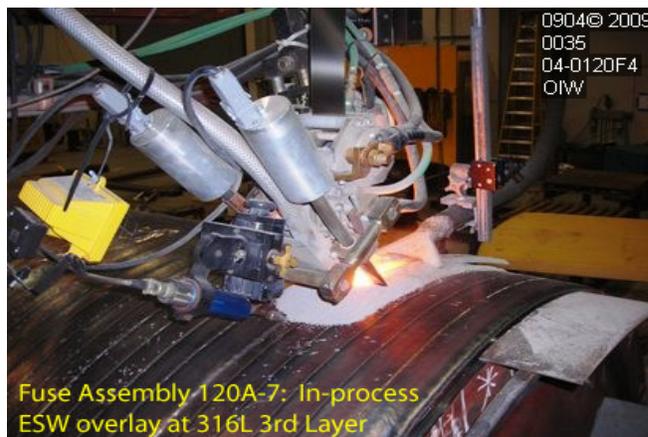
The QA Inspector intermittently observed OIW qualified welder Vincent Vu (WID V7) during in-process welding of Soudotape 316L stainless steel overlay to hinge k pipe beam fuse sub-assembly 120A-7. The weld joint is identified as 316L 3rd Layer. Mr. Vu was observed welding in the flat position utilizing automatic electro slag welding (ESW) overlay process with a .5mm x 60mm Soudotape 316L stainless electrode, filler metal brand Soudotape class EQ316L automatic. An OIW helper was observed assisting welder V7 during ESW activity. The QA Inspector observed OIW QC Inspector Steve Barnett regularly monitoring and recording the in process ESW parameters. The QA Inspector also intermittently observed in process welding parameters and determined that the ESW parameters (1200 amps, 25.2 volts, 242mm/min travel speed) and minimum preheat temperature of 70° F appeared to be in general compliance with the contract requirements and approved OIW Welding Procedure Specification (WPS) 7003. ESW activity was paused at about 2300 hours prior to shift turnover and was not resumed during graveyard shift.
