DEPARTMENT OF TRANSPORTATION

Contract #: 04-0120F4Cty: SF/ALA Rte: 80 PM: 13.2/13.9File #: 13.28**WELDING INSPECTION REPORT****Resident Engineer:** Pursell, Gary**Address:** 333 Burma Road**City:** Oakland, CA 94607**Report No:** WIR-008855**Date Inspected:** 04-Sep-2009**Project Name:** SAS Superstructure**OSM Arrival Time:** 1100**Prime Contractor:** American Bridge/Fluor Enterprises, a JV**OSM Departure Time:** 1930**Contractor:** Oregon Iron Works Clackamas, Or.**Location:** Clackamas, OR**CWI Name:** Mike Gregson, Jose Salazar**CWI Present:** Yes No**Inspected CWI report:** Yes No N/A**Rod Oven in Use:** Yes No N/A**Electrode to specification:** Yes No N/A**Weld Procedures Followed:** Yes No N/A**Qualified Welders:** Yes No N/A**Verified Joint Fit-up:** Yes No N/A**Approved Drawings:** Yes No N/A**Approved WPS:** Yes No N/A**Delayed / Cancelled:** Yes No N/A**Bridge No:** 34-0006**Component:** Hinge K Pipe Beams**Summary of Items Observed:**

Hinge-K Pipe Beam Assembly 102A-2: 9/4/09

Hinge-K Pipe Beam Fuse Assembly 120A-7: 9/4/09

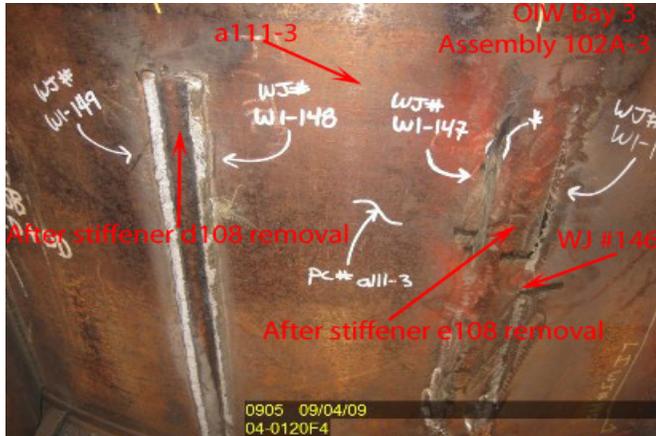
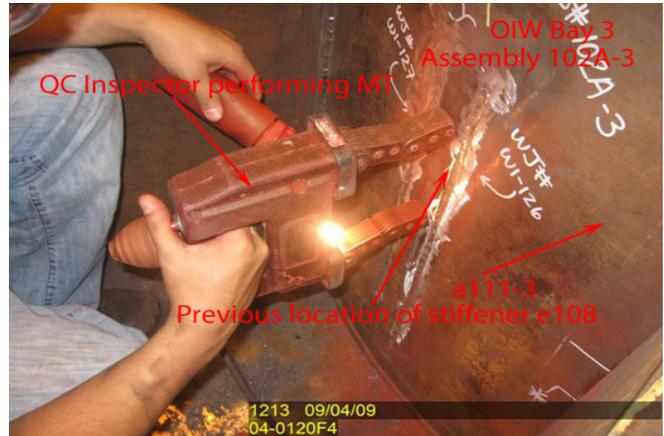
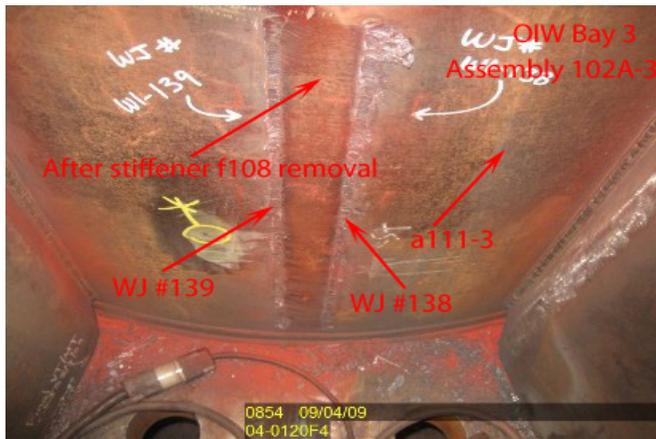
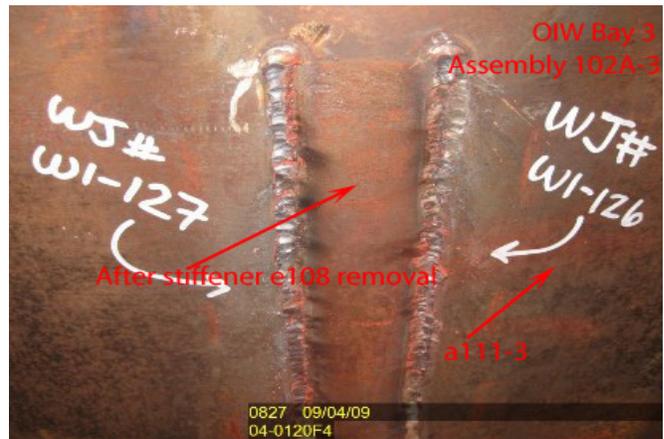
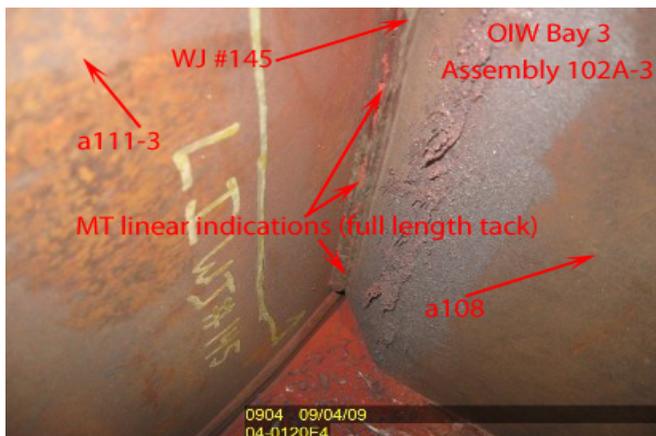
QA Inspector witnessed QC Inspector Jose Salazar performing 100% magnetic particle testing on the base metal of forging a111-3, after removal of the following stiffeners: e108 (WJ #126, 127), f108 (WJ #138, 139), c107 (WJ #142, 143), e108 (WJ #146, 147) and d108 (WJ #3148, 149). QA Inspector noted that after performing magnetic particle inspection on the full length tack welds on these stiffeners to a111-3 forging, that Mr. Salazar had previously found multiple linear indications, which were presumed to be cracks. Mr. Salazar explained to QA Inspector that these indications appeared, in most cases to run the full length of the tack welds and possibly into the base metal of the a111-3 forging. Mr. Salazar explained that these stiffeners were removed, to accommodate the 100% magnetic particle testing on the base metal. After performing the magnetic particle testing, Mr. Salazar explained that multiple linear indications were still present and OIW welder #H49, Mr. Rick Hinkle was in-process of grinding the indications, to possibly remove them. QA Inspector performed 100% magnetic particle inspection on all the full length tack welds, on the radial stiffeners and found additional linear indications, which appeared to be cracks, on the a108 stiffener to a111-3 forging (WJ # 145) and the b108 stiffener to a111-3 forging (WJ #160). QA Inspector notified QC Inspector of the testing results and Mr. Salazar explained that the indications would be ground out and magnetic particle inspection will be performed, after the grinding is completed. See attached pictures below.
