DEPARTMENT OF TRANSPORTATION

Quality Assurance and Source Inspection

Contract #: 04-0120F4Cty: SF/Ala Rte: 80 PM: 13.2/13.9File #: 69.28**WELDING INSPECTION REPORT****Resident Engineer:** Pursell, Gary**Address:** 333 Burma Road**City:** Oakland, CA 94607**Report No:** WIR-008865**Date Inspected:** 23-Aug-2009**Project Name:** SAS Superstructure**OSM Arrival Time:** 1900**Prime Contractor:** American Bridge/Fluor Enterprises, a JV**OSM Departure Time:** 700**Contractor:** Zhenhua Port Machinery Company, Ltd (ZPMC), Changxing Island **Location:** Shanghai, China

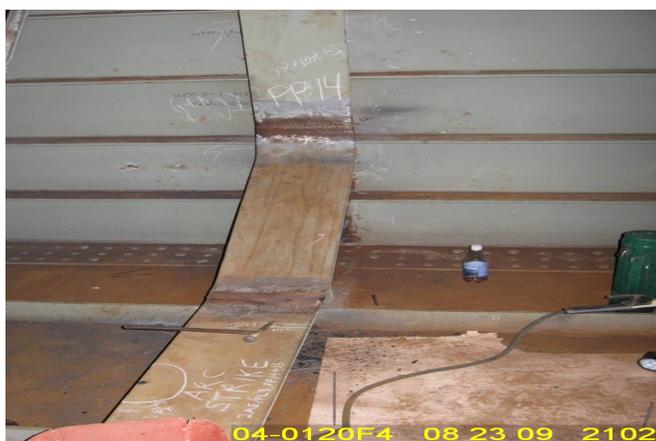
1AAW, – FCAW welding after UT indication and excavation of weld joint deck plate to eighth I-rib from south end. Welder was identified as 220063. ZPMC QC was identified as CWI Xu Yu Min (QC1). This QA Inspector, George Goulet, observed an arc strike on the flange of the longitudinal beam at approximately 1625mm east of panel point 14 and informed QC1. QC1 made a record of it and ensured this QA Inspector, George Goulet, that he would have the area ground and MT performed. The welding variables recorded by QC1 appeared to comply with WPS-345-SMAW-4G(4F)-repair. Also at this location was ABF Representative Kelvin Cheung (ABF1). ABF1 also made a record of the arc strike and ensured this QA Inspector, George Goulet, that the area would be ground and MT performed. See photo below of arc strike in foreground and top of above noted flange above weld area.

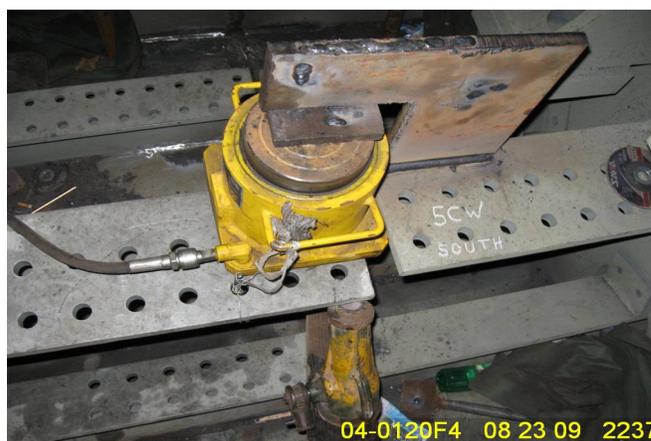
5BW/5CW south longitudinal diaphragm (LD) connection; 5BE/5CE north LD connection – misalignment of LD connections with jacking equipment in place. See photo below of 5BW/5CW south LD connection.
