Contract #: 04-0120F4Cty: SF/ALA Rte: 80 PM: 13.2/13.9File #: 13.28**WELDING INSPECTION REPORT****Resident Engineer:** Pursell, Gary**Address:** 333 Burma Road**City:** Oakland, CA 94607**Report No:** WIR-008880**Date Inspected:** 09-Sep-2009**Project Name:** SAS Superstructure**OSM Arrival Time:** 1900**Prime Contractor:** American Bridge/Fluor Enterprises, a JV**OSM Departure Time:** 330**Contractor:** Oregon Iron Works Clackamas, Or.**Location:** Clackamas, OR**CWI Name:** Steve Barnett, Jon Nickolich**CWI Present:** Yes No**Inspected CWI report:** Yes No N/A**Rod Oven in Use:** Yes No N/A**Electrode to specification:** Yes No N/A**Weld Procedures Followed:** Yes No N/A**Qualified Welders:** Yes No N/A**Verified Joint Fit-up:** Yes No N/A**Approved Drawings:** Yes No N/A**Approved WPS:** Yes No N/A**Delayed / Cancelled:** Yes No N/A**Bridge No:** 34-0006**Component:** Hinge-K Components**Summary of Items Observed:**

Summary of Items Observed: On this date, Caltrans Quality Assurance Inspector (QA) Clete Henke was present at Oregon Iron Works, Inc. (OIW) in Clackamas, OR for observation of fabrication of the Hinge K Pipe Beams and related activities including in process welding

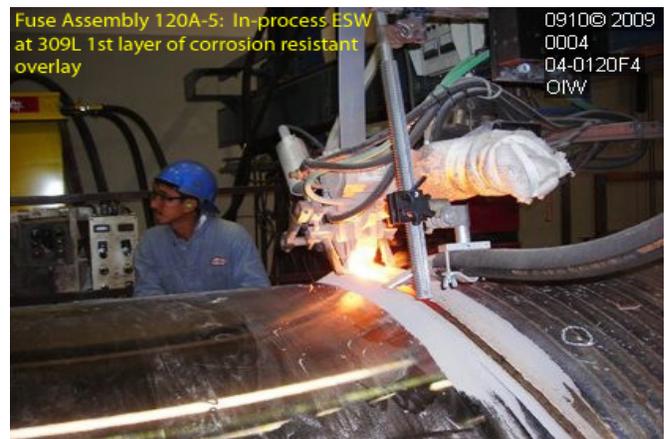
The QA Inspector intermittently observed OIW qualified welder Bounheune Savanh (WID S74) during in-process welding of Soudotape 309L stainless steel overlay to hinge k pipe beam fuse sub-assembly 120A-5. The weld joint is identified as 309L 1st layer. Mr. Savanh was observed welding in the flat position utilizing automatic electro slag welding (ESW) overlay process with a .5mm x 60mm Soudotape 309L stainless electrode, filler metal brand Soudotape class EQ309L automatic. An OIW helper was observed assisting welder S74 during ESW activity. The QA Inspector observed OIW QC Inspector Steve Barnett regularly monitoring and recording the in process ESW parameters. The QA Inspector also intermittently observed in process welding parameters and determined that the ESW parameters (1225 amps, 25.5 volts, 269mm/min travel speed) and minimum preheat temperature of 225° F appeared to be in general compliance with the contract requirements and approved OIW Welding Procedure Specification (WPS) 7003. ESW activity was paused at about 2300 hours prior to shift turnover and was not resumed during graveyard shift.
