**DEPARTMENT OF TRANSPORTATION**

Contract #: 04-0120F4Cty: SF/ALA Rte: 80 PM: 13.2/13.9File #: 13.28**WELDING INSPECTION REPORT****Resident Engineer:** Pursell, Gary**Address:** 333 Burma Road**City:** Oakland, CA 94607**Report No:** WIR-008882**Date Inspected:** 10-Sep-2009**Project Name:** SAS Superstructure**OSM Arrival Time:** 1900**Prime Contractor:** American Bridge/Fluor Enterprises, a JV**OSM Departure Time:** 330**Contractor:** Oregon Iron Works Clackamas, Or.**Location:** Clackamas, OR**CWI Name:** Steve Barnett, Jon Nickolich**CWI Present:** Yes No**Inspected CWI report:** Yes No N/A**Rod Oven in Use:** Yes No N/A**Electrode to specification:** Yes No N/A**Weld Procedures Followed:** Yes No N/A**Qualified Welders:** Yes No N/A**Verified Joint Fit-up:** Yes No N/A**Approved Drawings:** Yes No N/A**Approved WPS:** Yes No N/A**Delayed / Cancelled:** Yes No N/A**Bridge No:** 34-0006**Component:** Hinge-K Components**Summary of Items Observed:**

# WELDING INSPECTION REPORT

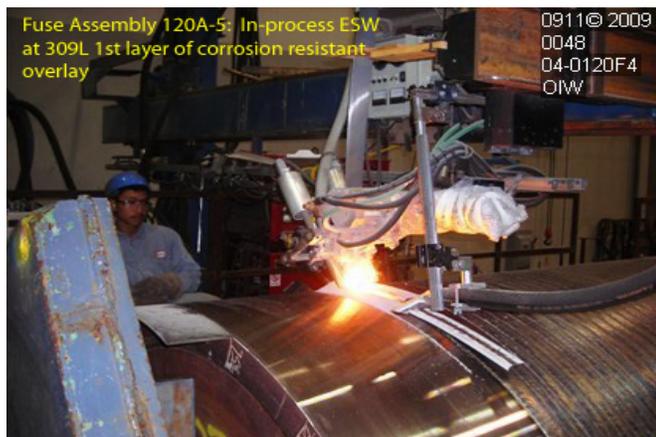
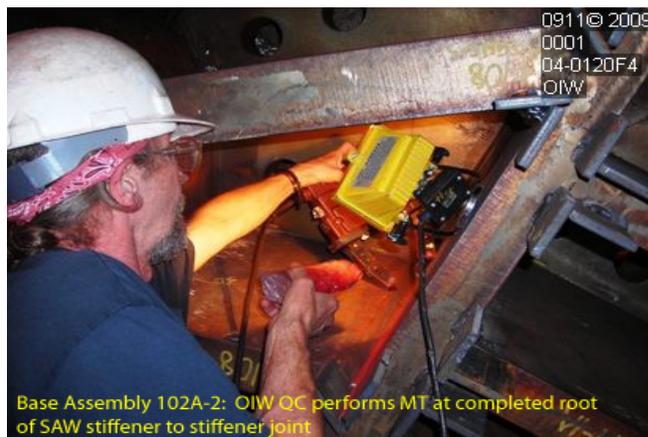
The QA Inspector intermittently monitored OIW welders Yuriy Bannikov (WID B61) and Phuong Huynh (WID H4) on swing shift and Harold Baldonado (WID B33) on graveyard shift during in progress Submerged Arc Welding (SAW) at weld joints W1-93, W1-120 & W1-118. The referenced connections join various radial stiffeners to a107 gussets. The QA Inspector observed as OIW QC Inspector Steve Barnett performed Magnetic particle Testing (MT) and Visual Inspection (VT) of completed root pass at weld joints referenced above. Mr. Barnett stated that he had located no rejectable indications. The QA Inspector subsequently performed 100% VT & 50% MT verification at the noted location W1-118 finding the root passes to be in general compliance with contract documents. Please reference TL-6028 report for this date for details. The QA Inspector intermittently observed as welders B61, H4 & B33 deposited SAW passes in the horizontal (2F) position in accordance with approved welding procedure 4020. The QA Inspector noted the OIW welders were maintaining continuous preheat utilizing a torch. Referenced connections W1-93 & W1-120 were completed during the swing shift and W1-118 was completed during graveyard shift. The QA Inspector observed OIW QC Inspectors Steve Barnett and Jon Nikolich regularly monitoring and recording the in process SAW parameters during swing and graveyard shift

respectively. The QA Inspector also intermittently observed in process welding parameters and determined that the SAW parameters and minimum preheat/interpass temperature appeared to be in general compliance with the contract requirements -- (W1-118: 35 volts, 565 amperes, 432mm/min travel speed ).

The QA Inspector intermittently observed OIW qualified welder Bounheune Savanh (WID S74) during in-process welding of Soudotape 309L stainless steel overlay to hinge k pipe beam fuse sub-assembly 120A-5. The weld joint is identified as 309L 1st layer. Mr. Savanh was observed welding in the flat position utilizing automatic electro slag welding (ESW) overlay process with a .5mm x 60mm Soudotape 309L stainless electrode, filler metal brand Soudotape class EQ309L automatic. An OIW helper was observed assisting welder S74 during ESW activity. The QA Inspector observed OIW QC Inspector Steve Barnett regularly monitoring and recording the in process ESW parameters. The QA Inspector also intermittently observed in process welding parameters and determined that the ESW parameters (1225 amps, 25.5 volts, 269mm/min travel speed) and minimum preheat temperature of 225° F appeared to be in general compliance with the contract requirements and approved OIW Welding Procedure Specification (WPS) 7003. ESW activity was paused at about 2300 hours prior to shift turnover and was not resumed during graveyard shift.
