Quality Assurance and Source Inspection

Contract #: 04-0120F4Cty: SF/ALA Rte: 80 PM: 13.2/13.9File #: 69.28**WELDING INSPECTION REPORT****Resident Engineer:** Pursell, Gary**Address:** 333 Burma Road**City:** Oakland, CA 94607**Report No:** WIR-009280**Date Inspected:** 25-Sep-2009**Project Name:** SAS Superstructure**OSM Arrival Time:** 700**Prime Contractor:** American Bridge/Fluor Enterprises, a JV**OSM Departure Time:** 1900**Contractor:** Zhenhua Port Machinery Company, Ltd (ZPMC), Changxing Island **Location:** Shanghai, China**CWI Name:** Chen Xi**CWI Present:** Yes No**Inspected CWI report:** Yes No N/A**Rod Oven in Use:** Yes No N/A**Electrode to specification:** Yes No N/A**Weld Procedures Followed:** Yes No N/A**Qualified Welders:** Yes No N/A**Verified Joint Fit-up:** Yes No N/A**Approved Drawings:** Yes No N/A**Approved WPS:** Yes No N/A**Delayed / Cancelled:** Yes No N/A**Bridge No:** 34-0006**Component:** OBG Crossbeams**Summary of Items Observed:**

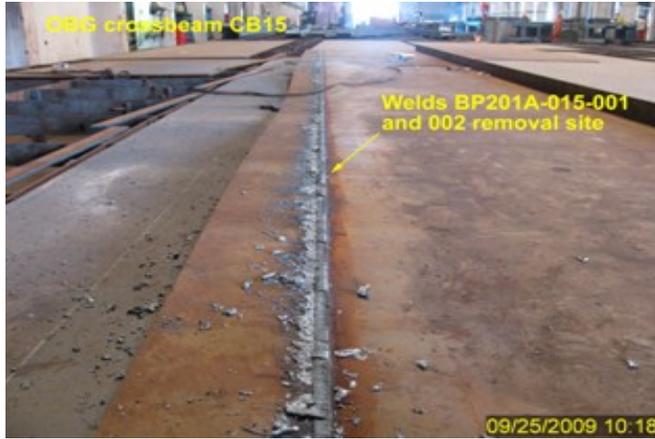
This QA observed that the contractor appears to have removed two Fracture Critical Welds (FCW) for their full length, without the Engineers approval. The welds in question joined one of the stiffeners to the SPCM bottom panel. QA observed the worker initially remove the stiffener using an oxy/fuel torch and later in the day QA observed another worker carbon arc gouging the remainder of the stiffener material and fillet welds. QA also observed another worker preheat the material prior to arc gouging as specified in the contract documents. The SPCM panel is identified on the approved shop drawings as BP201A. The welds are identified as

BP201A-015-001 and 002. AWS D1.5 2002 section 12.2.2.2 states "All welds to FCMs shall be considered fracture critical and shall conform to the requirements of this FCP..." AWS D1.5 2002 section 12.17.4 states "All critical repairs to base metal and welds shall be approved by the Engineer prior to beginning the repair and shall be documented giving details of the type of discontinuity and extent of repair".

AWS D1.5 2002 section 12.17.3 states "Except as provided in 12.17.2, all welded repairs shall be considered critical. They include, but are not limited to the following:

- (5) Corrections requiring weld removal and rewelding except as provided in 12.17.2(4).
- (6) All welding to correct errors in fabrication such as improper cutting, punching, drilling, machining, assembly, etc.

This QA notified ABF inspector identified as Mr. Chang Boa Qian and ZPMC QC CWI identified as Mr. Xu Xian Ping of the above mentioned issue and that an incident report would be generated. See attached photo for details.
