Contract #: 04-0120F4Cty: SF/ALA Rte: 80 PM: 13.2/13.9File #: 69.28**WELDING INSPECTION REPORT****Resident Engineer:** Pursell, Gary**Address:** 333 Burma Road**City:** Oakland, CA 94607**Report No:** WIR-009553**Date Inspected:** 26-Sep-2009**Project Name:** SAS Superstructure**OSM Arrival Time:** 700**Prime Contractor:** American Bridge/Fluor Enterprises, a JV**OSM Departure Time:** 1900**Contractor:** Zhenhua Port Machinery Company, Ltd (ZPMC), Changxing Island **Location:** Shanghai, China**CWI Name:** Lv Li Qing / Shen Fu You**CWI Present:** Yes No**Inspected CWI report:** Yes No N/A**Rod Oven in Use:** Yes No N/A**Electrode to specification:** Yes No N/A**Weld Procedures Followed:** Yes No N/A**Qualified Welders:** Yes No N/A**Verified Joint Fit-up:** Yes No N/A**Approved Drawings:** Yes No N/A**Approved WPS:** Yes No N/A**Delayed / Cancelled:** Yes No N/A**Bridge No:** 34-0006**Component:** OBG Assembly**Summary of Items Observed:**

OBG Assembly Bay 14

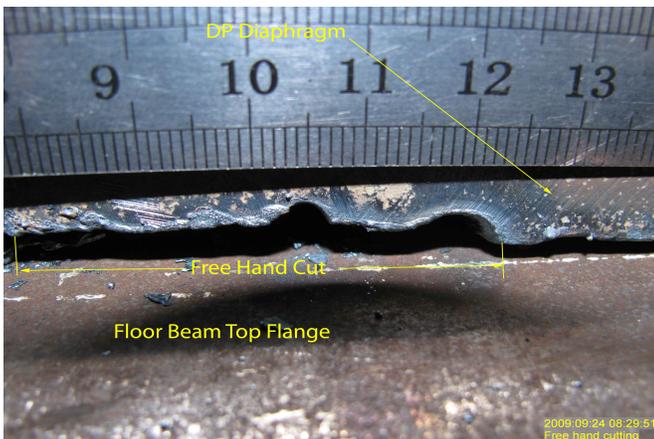
OBG Assembly 10BE PP89 ZPMC has performed flame cutting in order to fit up Deck Panel Diaphragm to Floor Beam. This cutting operation has produced several areas that are not uniform. See photograph for additional information.
