**DEPARTMENT OF TRANSPORTATION**

Contract #: 04-0120F4Cty: SF/ALA Rte: 80 PM: 13.2/13.9File #: 69.28**WELDING INSPECTION REPORT****Resident Engineer:** Pursell, Gary**Address:** 333 Burma Road**City:** Oakland, CA 94607**Report No:** WIR-009594**Date Inspected:** 14-Oct-2009**Project Name:** SAS Superstructure**OSM Arrival Time:** 700**Prime Contractor:** American Bridge/Fluor Enterprises, a JV**OSM Departure Time:** 1900**Contractor:** Zhenhua Port Machinery Company, Ltd (ZPMC), Changxing Island **Location:** Shanghai, China**CWI Name:** Chen Xi**CWI Present:** Yes No**Inspected CWI report:** Yes No N/A**Rod Oven in Use:** Yes No N/A**Electrode to specification:** Yes No N/A**Weld Procedures Followed:** Yes No N/A**Qualified Welders:** Yes No N/A**Verified Joint Fit-up:** Yes No N/A**Approved Drawings:** Yes No N/A**Approved WPS:** Yes No N/A**Delayed / Cancelled:** Yes No N/A**Bridge No:** 34-0006**Component:** OBG sub assemblies**Summary of Items Observed:**

**OBG BAY 5**

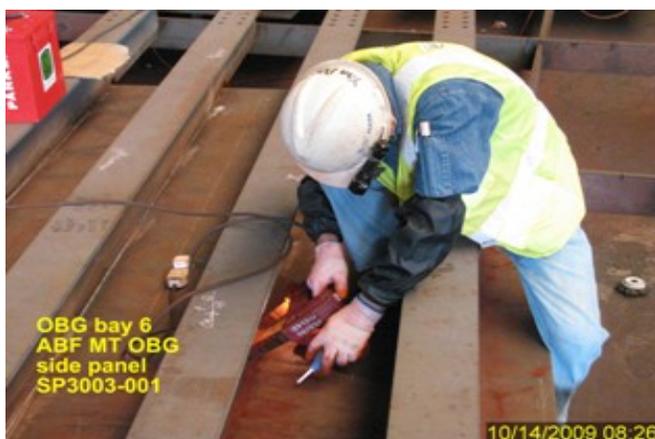
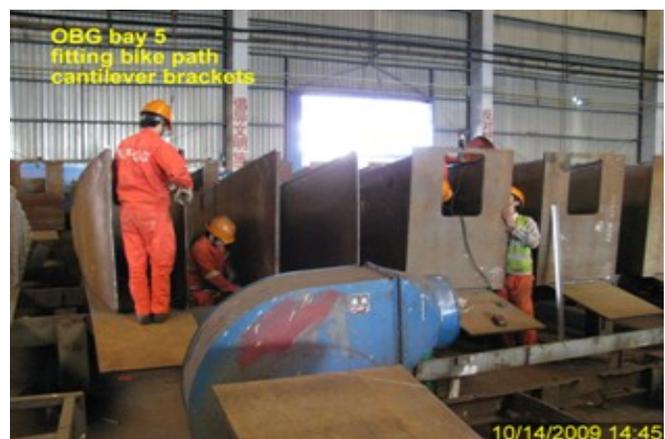
Unless otherwise noted, all work observed on this date appeared to be in general compliance with the applicable contract documents.
