DEPARTMENT OF TRANSPORTATION

Contract #: 04-0120F4Cty: SF/ALA Rte: 80 PM: 13.2/13.9File #: 69.28**WELDING INSPECTION REPORT****Resident Engineer:** Pursell, Gary**Address:** 333 Burma Road**City:** Oakland, CA 94607**Report No:** WIR-009627**Date Inspected:** 02-Oct-2009**Project Name:** SAS Superstructure**OSM Arrival Time:** 645**Prime Contractor:** American Bridge/Fluor Enterprises, a JV**OSM Departure Time:** 1745**Contractor:** Zhenhua Port Machinery Company, Ltd (ZPMC), Changxing Island **Location:** Shanghai, China**CWI Name:** Peng guo.**CWI Present:** Yes No**Inspected CWI report:** Yes No N/A**Rod Oven in Use:** Yes No N/A**Electrode to specification:** Yes No N/A**Weld Procedures Followed:** Yes No N/A**Qualified Welders:** Yes No N/A**Verified Joint Fit-up:** Yes No N/A**Approved Drawings:** Yes No N/A**Approved WPS:** Yes No N/A**Delayed / Cancelled:** Yes No N/A**Bridge No:** 34-0006**Component:** Tower Components**Summary of Items Observed:**

WELDING INSPECTION REPORT

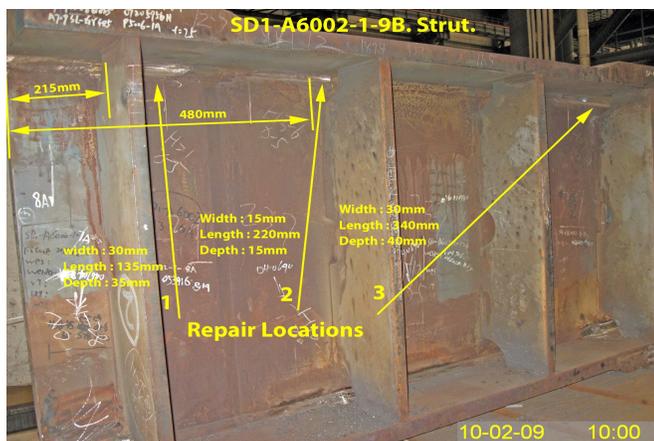
Bay11, South Tower, Struts Repair.

Repair gouge out noticed on strut weld Identified as SD1-A6002-1-9B. see attached picture for details.
