Contract #: 04-0120F4Cty: SF/ALA Rte: 80 PM: 13.2/13.9File #: 13.28**WELDING INSPECTION REPORT****Resident Engineer:** Pursell, Gary**Address:** 333 Burma Road**City:** Oakland, CA 94607**Report No:** WIR-009689**Date Inspected:** 19-Oct-2009**Project Name:** SAS Superstructure**OSM Arrival Time:** 700**Prime Contractor:** American Bridge/Fluor Enterprises, a JV**OSM Departure Time:** 1530**Contractor:** Oregon Iron Works Clackamas, Or.**Location:** Clackamas, OR

Bridge No: 34-0006**Component:** Hinge K Pipe Beams**Summary of Items Observed:**

Hinge-K Pipe Beam Assembly 102A-3: 10/19/09

Hinge-K Pipe Beam Assembly 102A-4: 10/19/09

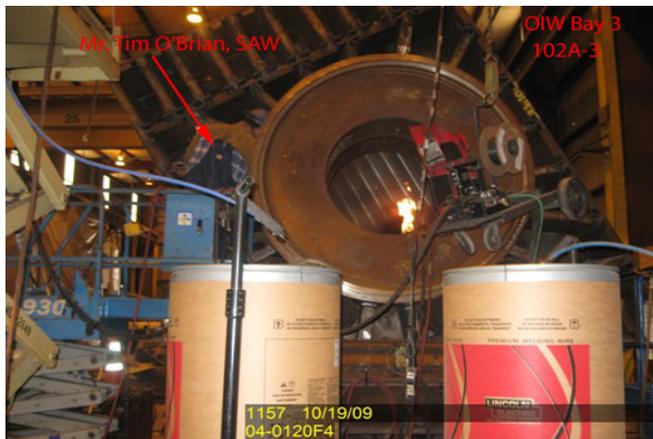
a111-3 Forging to a110-3 Base Plate

QA Inspector noticed this assembly 102A-3 had been previously placed in position and welder #06, Mr. Tim O'Brian, was in process of performing submerged arc welding, on the d107 stiffener plate to a111-3 tubular forging, designated as weld joint # W1-135, in the flat position. QA Inspector noted that this weld joint was designated as a partial joint penetration (AWS D1.5 TC-P5-S) and QA Inspector verified Mr. O'Brian was currently qualified for this process/position. QA Inspector noted that Mr. O'Brian was utilizing OIW approved welding procedure specification (WPS 4016) and randomly recorded pre-heat temperatures of approximately 350 degrees Fahrenheit (177 C). QA Inspector noticed QC Inspector Mike Gregson was present to monitor in-process welding parameters (amps/volts) and noted that Mr. Gregson had previously recorded in-process welding parameters of 563 amps and 35 volts, on the submerged arc welding cover passes. QA Inspector verified in-process welding parameters of 570 amps and 35 volts, which appears to be in compliance with the applicable welding procedure specification and contract requirements. See attached picture below.

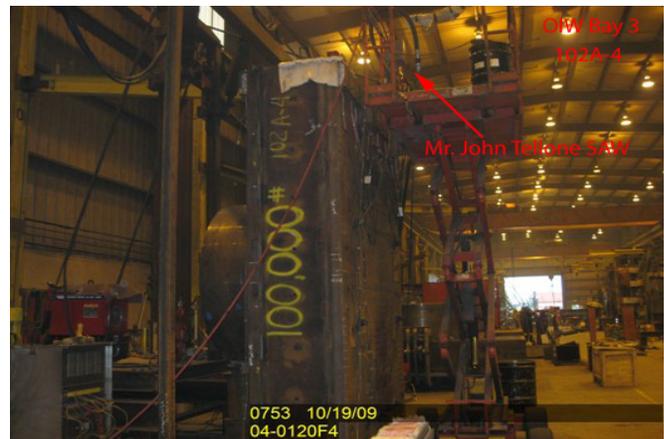
a111-4 Forging to a110-4 Base Plate

QA Inspector witnessed welder #T23 Mr. John Tellone, was currently in-process of performing submerged arc welding, on the a110 Base Plate to b106 stiffener, designated as weld joint #W2-18, in the flat (1G) position, utilizing OIW approved welding procedure specification (WPS 4020). QA Inspector noted that QC Inspector Mike Gregson, was present on this day and had previously verified the in-process welding parameters and pre-heat temperatures, to insure compliance with the applicable welding procedure specifications and AWS D1.5. QA Inspector reviewed Mr. Gregson's applicable documentation and noted that Mr. Gregson had previously recorded Mr. Tellone's in-process welding parameters of 570 amps/34 volts with a pre-heat temperature of approximately 350 degrees Fahrenheit (177 C). QA Inspector randomly performed an in-process verification of welding parameters and recorded amps/volts of 560/35 and a pre-heat temperature of approximately 350 degrees Fahrenheit (177 C). Mr. Tellone appeared to be in compliance with the applicable welding procedure specification and AWS D1.5, on this date. See attached picture below.
