**DEPARTMENT OF TRANSPORTATION**

Quality Assurance and Source Inspection

Contract #: 04-0120F4Cty: SF/ALA Rte: 80 PM: 13.2/13.9File #: 13.28**WELDING INSPECTION REPORT****Resident Engineer:** Pursell, Gary**Address:** 333 Burma Road**City:** Oakland, CA 94607**Report No:** WIR-010779**Date Inspected:** 16-Dec-2009**Project Name:** SAS Superstructure**OSM Arrival Time:** 1000**Prime Contractor:** American Bridge/Fluor Enterprises, a JV**OSM Departure Time:** 1830**Contractor:** Oregon Iron Works Clackamas, Or.**Location:** Clackamas, OR**CWI Name:** M. Gregson, J. Salazar**CWI Present:** Yes No**Inspected CWI report:** Yes No N/A**Rod Oven in Use:** Yes No N/A**Electrode to specification:** Yes No N/A**Weld Procedures Followed:** Yes No N/A**Qualified Welders:** Yes No N/A**Verified Joint Fit-up:** Yes No N/A**Approved Drawings:** Yes No N/A**Approved WPS:** Yes No N/A**Delayed / Cancelled:** Yes No N/A**Bridge No:** 34-0006**Component:** Hinge K Pipe Beams**Summary of Items Observed:**

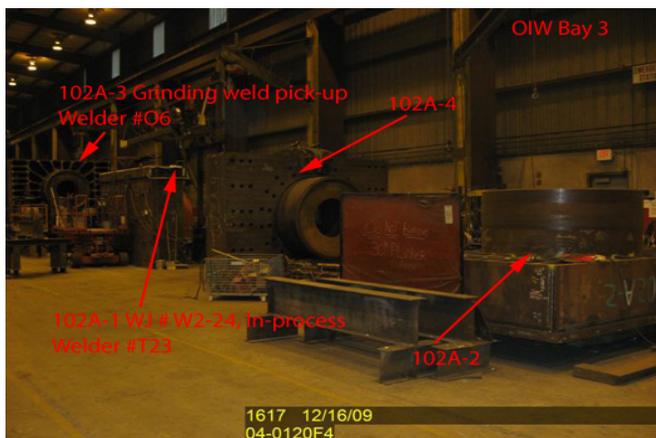
The QA Inspector noted that OIW welder # O6, Mr. Tim O'Brian was continuing to blend the weld start/stops, removing weld spatter and grinding all areas, which were previously marked by OIW QC Inspectors. The QA Inspector noted that these areas were on the previously completed submerged arc welded (SAW), HPS 485W stiffeners, designated as weld joints #W1-01 thru W1-163. The QA Inspector spoke with QC Inspector Jose Salazar and Mr. Salazar explained that the visual clean-up that was being performed by Mr. O'Brian, was intermittently monitored and areas that were completed, were then visually re-inspected. Mr. Salazar explained to the QA Inspector that he had performed 100% magnetic particle testing on the following partial penetration weld joints: #W1-127, W1-161, W1-162 and W1-163. Mr. Salazar explained that the above mentioned weld joints were visually acceptable per AWS D1.5 and no rejectable indications were found, during the magnetic particle testing.

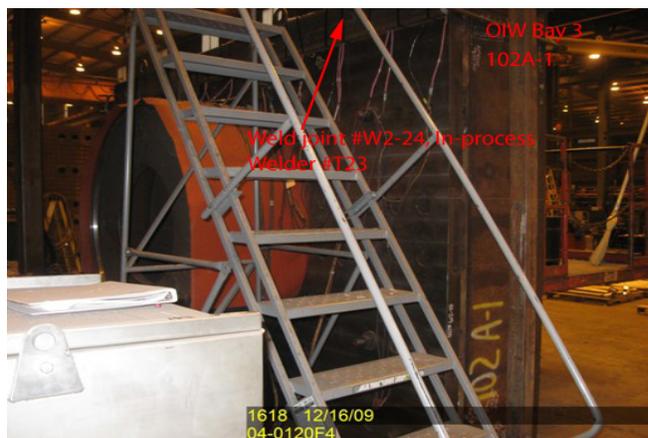
The QA Inspector noted that welder #T23, Mr. John Tellone, was continuing to performing the submerged arc welding (SAW) on the a109 Post Tension Cap Plate to ab106 stiffener. The QA Inspector noted that this weld joint

was designated as #W2-24/partial joint penetration (AWS D1.5 TC-P4-S) and Mr. Tellone was performing the SAW in the flat (1G) position. The QA Inspector noted that Mr. Tellone was utilizing OIW approved welding procedure specification (WPS 4020). The QA Inspector noted that QC Inspector Jose Salazar, was present and intermittently verified the in-process welding parameters and pre-heat temperatures. The QA Inspector spoke with QC Inspector Jose Salazar and Mr. Salazar explained that welding parameters were recorded at 563 amps/35 volts, with a pre-heat of approximately 350 degrees Fahrenheit (177 C). QA Inspector randomly verified pre-heat of approximately 350 degrees Fahrenheit (177 C). The QA Inspector noted that the SAW performed by Mr. Tellone appeared to be in compliance with AWS D1.5 and WPS 4020.
