Contract #: 04-0120F4Cty: SF/ALA Rte: 80 PM: 13.2/13.9File #: 99.28**WELDING INSPECTION REPORT****Resident Engineer:** Pursell, Gary**Address:** 333 Burma Road**City:** Oakland, CA 94607**Report No:** WIR-011552**Date Inspected:** 18-Jan-2010**Project Name:** SAS Superstructure**OSM Arrival Time:** 730**Prime Contractor:** American Bridge/Fluor Enterprises, a JV**OSM Departure Time:** 1630**Contractor:** Watson Bowman Acme / K.D.M.**Location:** Amherst / Buffalo, NY**CWI Name:** Greg Ross**CWI Present:** Yes No**Inspected CWI report:** Yes No N/A**Rod Oven in Use:** Yes No N/A**Electrode to specification:** Yes No N/A**Weld Procedures Followed:** Yes No N/A**Qualified Welders:** Yes No N/A**Verified Joint Fit-up:** Yes No N/A**Approved Drawings:** Yes No N/A**Approved WPS:** Yes No N/A**Delayed / Cancelled:** Yes No N/A**Bridge No:** 34-0006**Component:** Seismic Joint (Hinge AW & AE)**Summary of Items Observed:**

On this date, Caltrans Quality Assurance Inspector (QA) Sherri Brannon is present at the Watson Bowman Acme (WBA) facility in Amherst, New York for the purpose of observing Procedure Qualification Record (PQR) test fabrication of the Seismic Joint (Hinge AW & AE).

# WEL

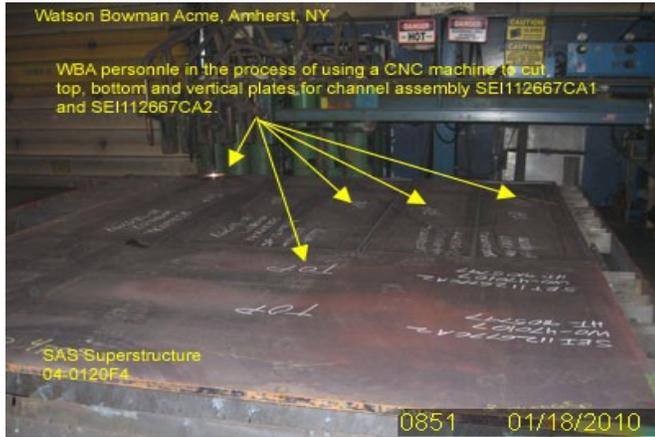
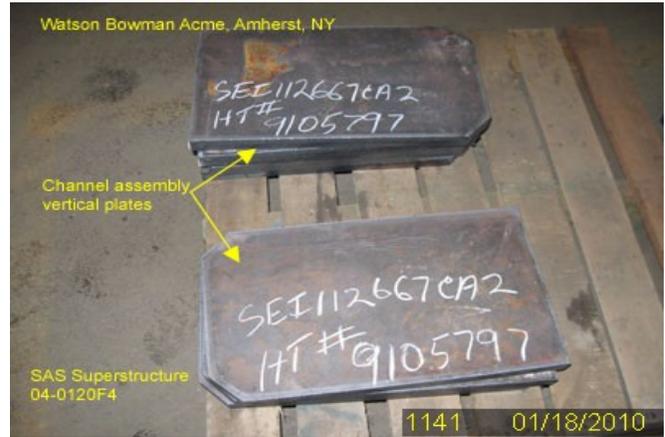
QA Inspector Brannon randomly observed WBA personnel flame cutting steel plates for the purpose of fabricating seismic joint A. The QA observed WBA in the process of using a cnc burning machine to cut the ASTM A709 345M steel plates for the top, bottom and vertical steel plates for channel assembly SEI112667CA1 and SEI112667CA2. The identified heat number for the steel plates being cut is heat # 9105797. During QA observation, QA observed no problems in the cutting process. Quality Control Mr. John Miller informed QA Inspector Brannon that a total of 24 top plates, 4 bottom plates and 36 vertical plates for the channel assembly have been cut to date.

The following digital photograph below illustrates observation of the activities being performed.
