DEPARTMENT OF TRANSPORTATION

Contract #: 04-0120F4Cty: SF/ALA Rte: 80 PM: 13.2/13.9File #: 99.28**WELDING INSPECTION REPORT****Resident Engineer:** Pursell, Gary**Address:** 333 Burma Road**City:** Oakland, CA 94607**Report No:** WIR-011766**Date Inspected:** 22-Jan-2010**Project Name:** SAS Superstructure**OSM Arrival Time:** 800**Prime Contractor:** American Bridge/Fluor Enterprises, a JV**OSM Departure Time:** 1630**Contractor:** Watson Bowman Acme**Location:** Amherst, New York**CWI Name:** John Miller, Greg Ross**CWI Present:** Yes No**Inspected CWI report:** Yes No N/A**Rod Oven in Use:** Yes No N/A**Electrode to specification:** Yes No N/A**Weld Procedures Followed:** Yes No N/A**Qualified Welders:** Yes No N/A**Verified Joint Fit-up:** Yes No N/A**Approved Drawings:** Yes No N/A**Approved WPS:** Yes No N/A**Delayed / Cancelled:** Yes No N/A**Bridge No:** 34-0006**Component:** Seismic Joint (Hinge AW & AE)**Summary of Items Observed:**

On this date, Caltrans Quality Assurance Inspector (QA) Sherri Brannon is present at the Watson Bowman Acme (WBA) facility in Amherst, New York for the purpose of observing Procedure Qualification Record (PQR) test fabrication of the Seismic

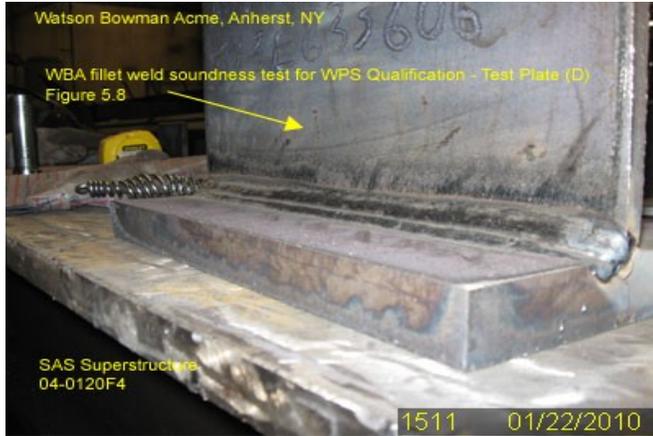
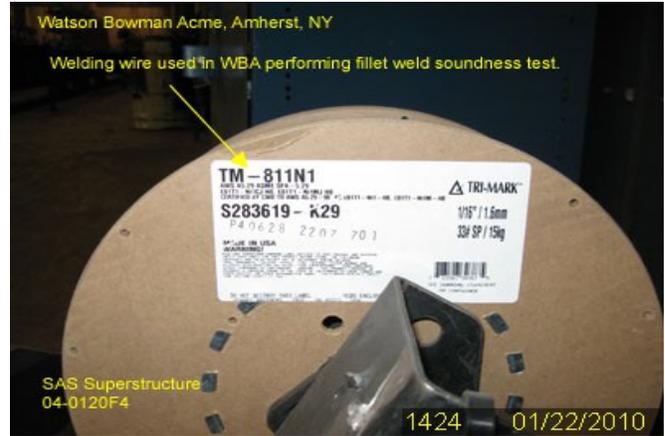
Caltrans Quality Assurance Inspector Sherri Brannon observed Watson Bowman Acme (WBA) welder Mr. Vincent Gebeczyk performing a flux core arc welding (FCAW) Figure 5.8 WPS Verification - Fillet Weld Soundness test (macroetch) for WPS Qualification - Test Plate (D) qualifying PQR is NY-WBA-08-3J. The QA Inspector observed Mr. Gebeczyk deposit (1) 1/4 inch single fillet weld pass on one side of the fillet weld soundness test plate and (3) multiple fillet weld passes on the other side of the fillet weld soundness test plate. Mr. Gebeczyk was observed welding in the horizontal (2F) position. Base plate material was identified as ASTM A709M Gr. 345 HT#5101277, and vertical plate is identified as ASTM A36-HT#1002469. The QA Inspector observed Mr. Gebeczyk utilizing CO2 100% shielding gas and 1.6 millimeter (mm) diameter Hobart Brothers class E81T1-Nil electrode. The QA Inspector observed Quality Control (QC) Inspector Mr. John Miller and Mr. Greg Ross as they monitored welding parameters. The QA Inspector verified the parameters that Mr. Miller and Mr. Ross recorded utilizing his Fluke 337 True RMS Clamp Meter and a stop watch. The QA Inspector assigned Lot number B208-009-10 as witness to the test. Note: Reference document Request For Information (RFI) ABF-RFI-002017R00. See Caltrans Welding Witness Report, TL-6032 dated January 22, 2010 for additional information.

The following digital photograph below illustrates observation of the activities being performed.
