DEPARTMENT OF TRANSPORTATION

Contract #: 04-0120F4Cty: SF/ALA Rte: 80 PM: 13.2/13.9File #: 1.28**WELDING INSPECTION REPORT****Resident Engineer:** Pursell, Gary**Address:** 333 Burma Road**City:** Oakland, CA 94607**Report No:** WIR-011994**Date Inspected:** 11-Feb-2010**Project Name:** SAS Superstructure**OSM Arrival Time:** 700**Prime Contractor:** American Bridge/Fluor Enterprises, a JV**OSM Departure Time:** 1530**Contractor:** American Bridge/Fluor Enterprises, a JV**Location:** Job Site

OBG 4E post arrival inspection

Weld Joint 1/E/2E-A

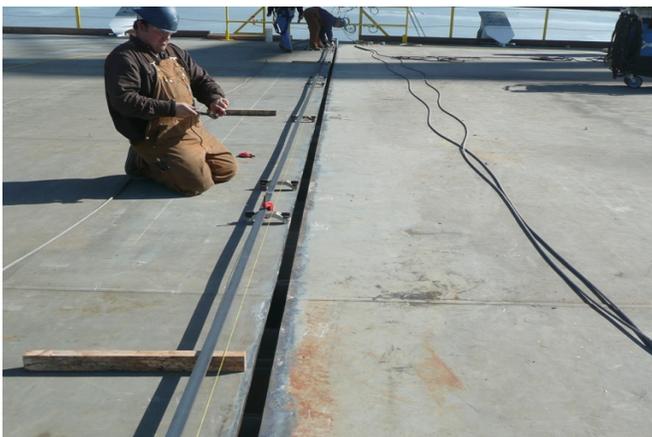
The QA Inspector randomly observed the two identified OBG’s “A” face appeared to be approximately 75mm apart. The QA Inspector randomly observed the ABF welding representatives identified above had previously cut and ground bevels in 5 total sections of the 1-1/2” steel backing (pictured below). The QA Inspector noted the steel backing was being fit up in accordance with pre qualified weld joint designated Bu46. The QA Inspector verified a 45° single bevel for a total of 4 CJP weld splices in the steel backing. The QA Inspector randomly observed and noted the Smith Emery Quality Control (QC) representatives Steve McConnell, Mike Johnson and Leonard Cross were on site performing visual testing (VT) of the fit up of steel backing prior to welding.

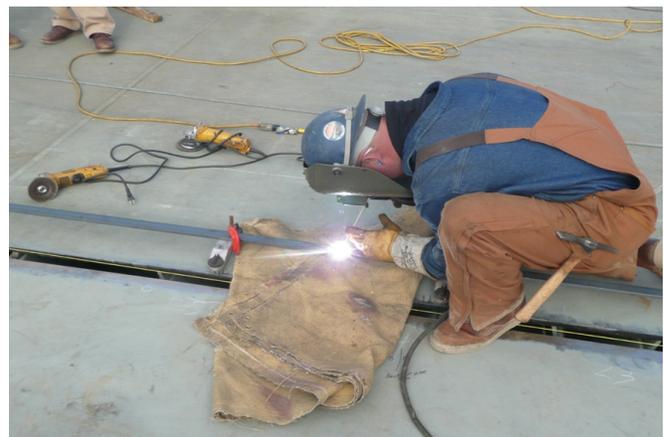
After the fit up of the steel backing was accepted by the QC Inspectors, the QA Inspector randomly observed the ABF welder Jordan Hazelaar perform shielded metal arc welding (SMAW) root passes in all 4 of the fit up grooves after preheating to 100°F with a rosebud torch (pictured below). The QA Inspector randomly observed the SE QC Inspector Mike Johnson performing preheat verifications utilizing a digital heat gun.
