Contract #: 04-0120F4Cty: SF/ALA Rte: 80 PM: 13.2/13.9File #: 69.28**WELDING INSPECTION REPORT****Resident Engineer:** Pursell, Gary**Address:** 333 Burma Road**City:** Oakland, CA 94607**Report No:** WIR-012020**Date Inspected:** 10-Feb-2010**Project Name:** SAS Superstructure**OSM Arrival Time:** 645**Prime Contractor:** American Bridge/Fluor Enterprises, a JV**OSM Departure Time:** 1845**Contractor:** Zhenhua Port Machinery Company, Ltd (ZPMC), Changxing Island **Location:** Shanghai, China**CWI Name:** Wu Zhi Cheng**CWI Present:** Yes No**Inspected CWI report:** Yes No N/A**Rod Oven in Use:** Yes No N/A**Electrode to specification:** Yes No N/A**Weld Procedures Followed:** Yes No N/A**Qualified Welders:** Yes No N/A**Verified Joint Fit-up:** Yes No N/A**Approved Drawings:** Yes No N/A**Approved WPS:** Yes No N/A**Delayed / Cancelled:** Yes No N/A**Bridge No:** 34-0006**Component:** OBG**Summary of Items Observed:**

WELDING INSPECTION REPORT

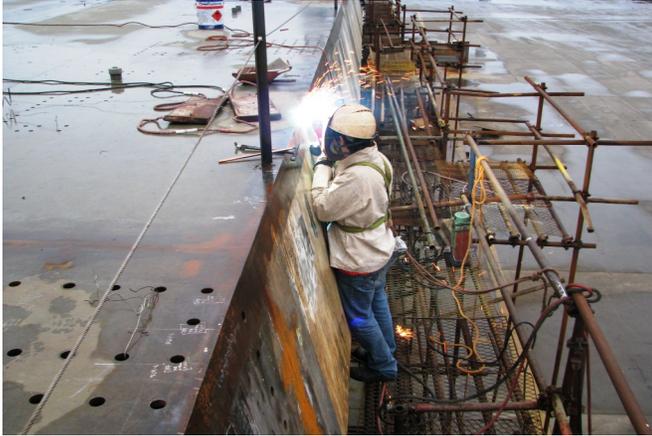
Shield Metal Arc Welding (SMAW) welding was performed on weld joint 001 located at OBW7M on counter weight side of segment. Welder is identified as Mr. Zhao Aifei (067942). ZPMC QC is identified as Wu Zhi Cheng. The welding variables monitored and recorded by the QC appeared to comply with WPS-B-P-2214-Tc-U4b.

Welding was performed on weld joint OBW7M -001 by ZPMC approved welder 067942.
