Contract #: 04-0120F4Cty: SF/ALA Rte: 80 PM: 13.2/13.9File #: 69.28**WELDING INSPECTION REPORT****Resident Engineer:** Pursell, Gary**Address:** 333 Burma Road**City:** Oakland, CA 94607**Report No:** WIR-012190**Date Inspected:** 24-Jan-2010**Project Name:** SAS Superstructure**OSM Arrival Time:** 645**Prime Contractor:** American Bridge/Fluor Enterprises, a JV**OSM Departure Time:** 1845**Contractor:** Zhenhua Port Machinery Company, Ltd (ZPMC), Changxing Island **Location:** Shanghai, China**CWI Name:** As identified below**CWI Present:** Yes No**Inspected CWI report:** Yes No N/A**Rod Oven in Use:** Yes No N/A**Electrode to specification:** Yes No N/A**Weld Procedures Followed:** Yes No N/A**Qualified Welders:** Yes No N/A**Verified Joint Fit-up:** Yes No N/A**Approved Drawings:** Yes No N/A**Approved WPS:** Yes No N/A**Delayed / Cancelled:** Yes No N/A**Bridge No:** 34-0006**Component:** OBG**Summary of Items Observed:**

WELDING INSPECTION REPORT

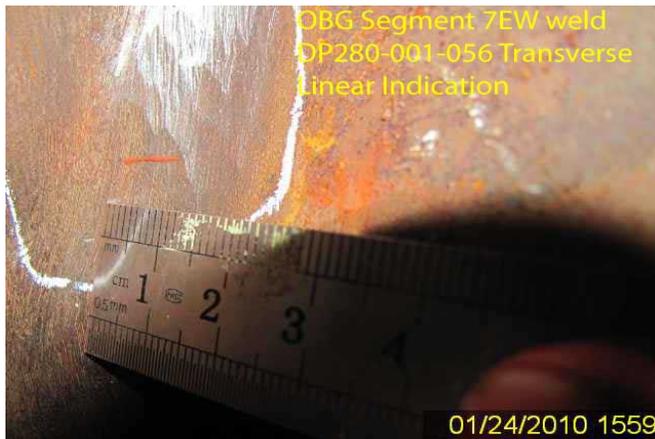
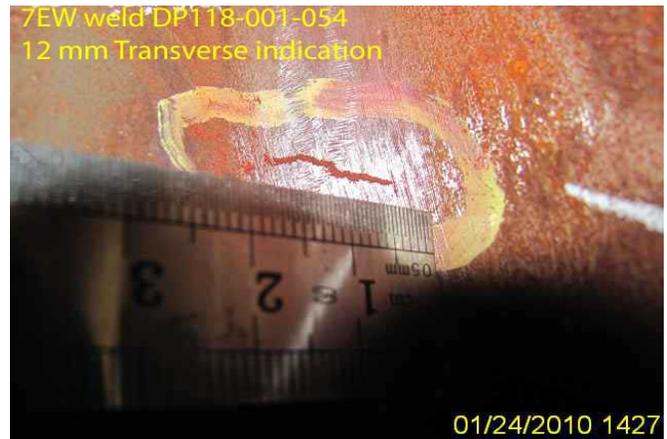
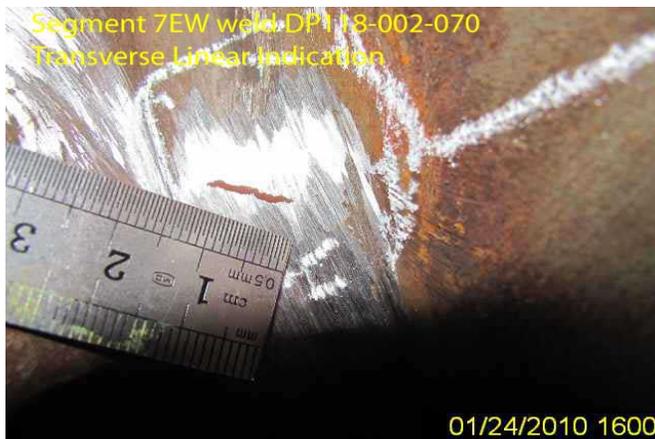
The following welds were rejected by Caltrans QA:
DP280-001-056 (9mm Transverse Linear Indication)
DP118-001-054 (12mm Transverse Linear Indication)
DP118-002-070 (12mm Transverse Linear Indication)

An Incident Report was issued for the above mentioned MT indications. For additional information please see the attached photographs below.
