DEPARTMENT OF TRANSPORTATION

Quality Assurance and Source Inspection

Contract #: 04-0120F4Cty: SF/ALA Rte: 80 PM: 13.2/13.9File #: 19.28**WELDING INSPECTION REPORT****Resident Engineer:** Pursell, Gary**Address:** 333 Burma Road**City:** Oakland, CA 94607**Report No:** WIR-012243**Date Inspected:** 22-Feb-2010**Project Name:** SAS Superstructure**OSM Arrival Time:** 1300**Prime Contractor:** American Bridge/Fluor Enterprises, a JV**OSM Departure Time:** 2130**Contractor:** American Bridge/Fluor Enterprises, a JV**Location:** Job Site**CWI Name:** See Report Below**CWI Present:** Yes No**Inspected CWI report:** Yes No N/A**Rod Oven in Use:** Yes No N/A**Electrode to specification:** Yes No N/A**Weld Procedures Followed:** Yes No N/A**Qualified Welders:** Yes No N/A**Verified Joint Fit-up:** Yes No N/A**Approved Drawings:** Yes No N/A**Approved WPS:** Yes No N/A**Delayed / Cancelled:** Yes No N/A**Bridge No:** 34-0006**Component:** Orthotropic Box Girders**Summary of Items Observed:**

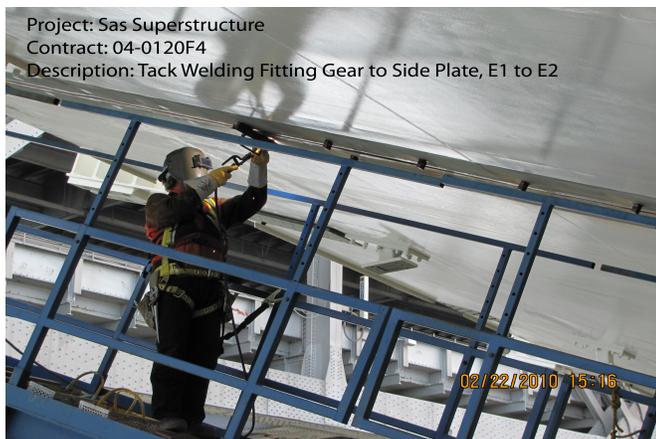
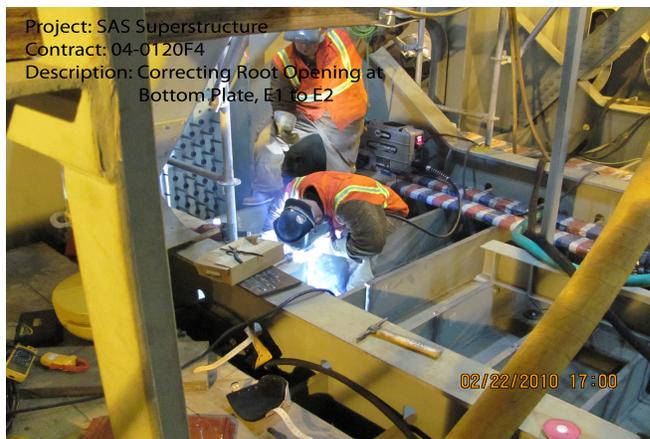
The QA inspector observed the Shielded Metal Arc Welding (SMAW) process of the field assembly gear fitting aids and the welding to correct the root opening dimensions of the E1 to E2 bottom plate splice. The welding was performed utilizing the Welding Procedure Specification's (WPS's) ABF-WPS-D15-F1200A-1 and ABF-WPS-D15-F3200-2 which was also used by the AB/F Quality Control (QC) inspector's Jesse Cabbyabyab Steve McConnell and Tom Pasqualone during the monitoring of the welding parameters. The welding parameters and preheat temperatures were verified and noted utilizing a Fluke 337 clamp meter for the electrical welding parameters and a Fluke 63 IR Thermometer for preheat and interpass temperatures. The Lincoln and ESAB 3.2 mm for the SMAW process and 1.4mm for the FCAW-G process consumables was also verified by the QC inspectors and appeared to comply with the AWS Electrode Classification E7018 and E71T-1M. The QC inspector's appeared to perform the visual examinations and monitoring of the welding as per the contract documents. The welding and inspection on this shift was not completed except as noted and appeared to be in general compliance with the contract documents.

See digital photographs below in regards to the work observed during this shift.
