DEPARTMENT OF TRANSPORTATION

Contract #: 04-0120F4Cty: SF/ALA Rte: 80 PM: 13.2/13.9File #: 13.28**WELDING INSPECTION REPORT****Resident Engineer:** Pursell, Gary**Address:** 333 Burma Road**City:** Oakland, CA 94607**Report No:** WIR-012275**Date Inspected:** 25-Feb-2010**Project Name:** SAS Superstructure**OSM Arrival Time:** 1000**Prime Contractor:** American Bridge/Fluor Enterprises, a JV**OSM Departure Time:** 1830**Contractor:** Oregon Iron Works Clackamas, Or.**Location:** Clackamas, OR**CWI Name:** M. Gregson, J. Salazar**CWI Present:** Yes No**Inspected CWI report:** Yes No N/A**Rod Oven in Use:** Yes No N/A**Electrode to specification:** Yes No N/A**Weld Procedures Followed:** Yes No N/A**Qualified Welders:** Yes No N/A**Verified Joint Fit-up:** Yes No N/A**Approved Drawings:** Yes No N/A**Approved WPS:** Yes No N/A**Delayed / Cancelled:** Yes No N/A**Bridge No:** 34-0006**Component:** Hinge K Pipe Beams**Summary of Items Observed:**

Hinge-K Pipe Beam Assembly 102A-2:

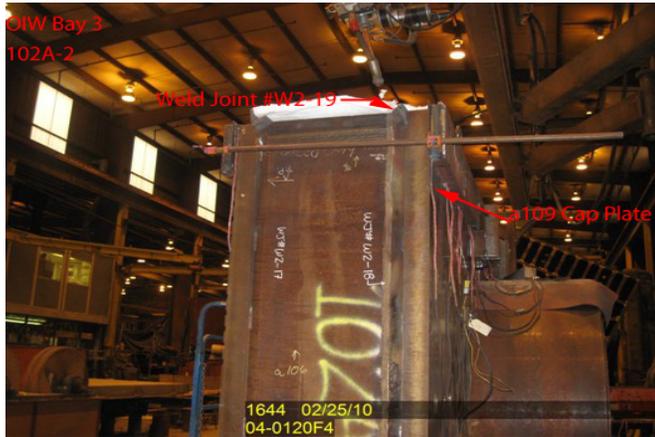
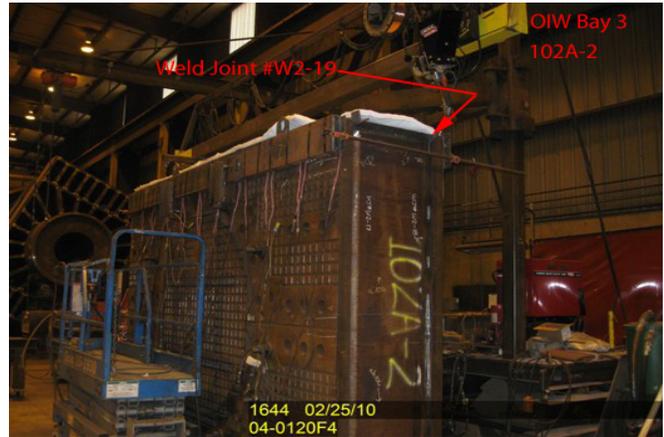
The QA Inspector witnessed WID #B62 (Marcus Belgarde), performing the submerged arc welding (SAW) on the a109 Post Tension Cap plate to a106 HPS 485W stiffener. The QA Inspector noted that this weld joint was designated as a partial joint penetration (AWS D1.5 TC-P4-S), weld joint #W2-19 and WID #B62 was performing the SAW in the flat (1G) position. The QA Inspector noted that the SAW cover passes were currently in-process and noted that the OIW approved welding procedure specification (WPS 4020), was being utilized. The QA Inspector noted that QC Inspector Jose Salazar, was present and QC Inspector Salazar explained that the in-process welding parameters/pre-heat temperatures, were intermittently verified. QC Inspector Salazar explained that average welding parameters for these SAW cover passes, was recorded at 600 amps/34.6 volts, with a pre-heat of approximately 350 degrees Fahrenheit (177 C). The QA Inspector randomly verified pre-heat of approximately 350 degrees Fahrenheit (177 C) and welding parameters to be in compliance with the applicable WPS 4020. The QA Inspector noted that the SAW appeared to be in-compliance with AWS D1.5 and the applicable WPS 4020.
