Contract #: 04-0120F4Cty: SF/ALA Rte: 80 PM: 13.2/13.9File #: 19.28**WELDING INSPECTION REPORT****Resident Engineer:** Pursell, Gary**Address:** 333 Burma Road**City:** Oakland, CA 94607**Report No:** WIR-012279**Date Inspected:** 27-Feb-2010**Project Name:** SAS Superstructure**OSM Arrival Time:** 830**Prime Contractor:** American Bridge/Fluor Enterprises, a JV**OSM Departure Time:** 1700**Contractor:** American Bridge/Fluor Enterprises, a JV**Location:** Job Site**CWI Name:** J. Cayabyab**CWI Present:** Yes No**Inspected CWI report:** Yes No N/A**Rod Oven in Use:** Yes No N/A**Electrode to specification:** Yes No N/A**Weld Procedures Followed:** Yes No N/A**Qualified Welders:** Yes No N/A**Verified Joint Fit-up:** Yes No N/A**Approved Drawings:** Yes No N/A**Approved WPS:** Yes No N/A**Delayed / Cancelled:** Yes No N/A**Bridge No:** 34-0006**Component:** Orthotropic Box Girders**Summary of Items Observed:**

A). Field Splice E1 to E2.

WELDING INSPECTION REPORT

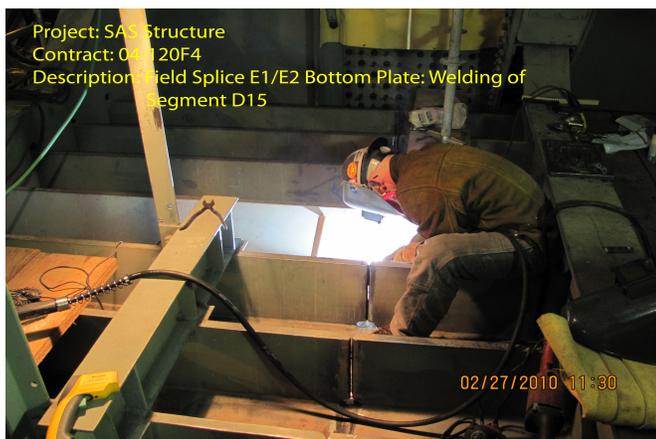
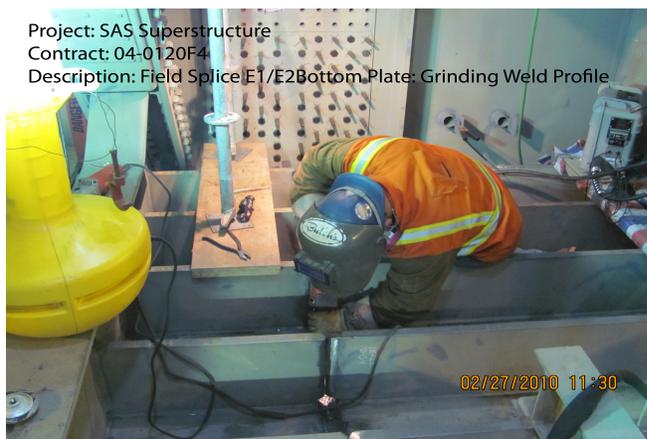
The QAI observed the continued Complete Joint Penetration (CJP) groove welding of the bottom plate splice identified as Weld Number (WN) "D1" and "D2", segments D3, D4 and D15. The welding was performed by AB/F personnel Jordan Hazelaar, ID-2135 and Jeremy Dolman, ID-5042. The QAI also observed Quality Control (QC) inspector Jesse Cayabyab verify the Direct Current (DC) welding parameters and the surface temperatures during the welding process and the average readings were noted as follows: 263 amps, 23.8 volts with a travel speed measured between 343mm and 385mm per minute. The surface temperatures were noted by the QC inspector as follows: minimum preheat temperature of 100 degrees Celsius and the maximum interpass temperature of 230 degrees Celsius. At the conclusion of the welding of the segments the QAI observed the QC inspector, Mr. Cayabyab perform the Visual Inspection (VT) of the Weld Segments identified as D3, D4 and D15. At the conclusion of the welding and minor profile grinding, the QC inspector performed a VT weld inspection and no rejectable discontinuities were noted. QAI concurs with the QC inspector's interpretation. The welding was completed on the D15 segment at approximately 1345 and the surface temperature was noted as 107 degrees Celsius and D3 and D4 segments were completed at approximately 1530 and the surface temperature was noted 115 degrees Celsius. At this time AB/F personnel commence the three (3) hours preheat hold time as required by the Project Special Provisions. The preheat hold time on the segments was not completed prior to the departure of the QAI.

The QA inspector observed Flux Cored Arc Welding (FCAW-G) process of the bottom plate field splice E1 to E2 identified as WN 1E-2E-D1 and D2. The welding was performed utilizing the Welding Procedure Specification (WPS) ABF-WPS-D15-3040A-1 Rev. 0 utilizing the welding parameters noted on the WPS as per AWS D1. 5-02/Section 5.12. The WPS was also used by the AB/F Quality Control (QC) inspector Jesse Cayabyab during the monitoring of the welding. The welding parameters and preheat temperatures were verified and noted utilizing a Fluke 337 clamp meter for the electrical welding parameters and a Fluke 63 IR Thermometer for verifying the preheat and interpass temperatures. The consumables utilized during the welding appeared to be an ESAB manufactured product identified as ESAB Dual Shield 70 Ultra Plus with an electrode size of 1.4mm. The consumable appeared to comply with the AWS Electrode Specification AWS A5.20 and the AWS Classification E71T-1M. The QC inspector appeared to perform the visual examinations and monitoring of the welding as per the contract documents. The welding and QC inspection performed on this shift was not completed except as noted above and appeared to be in general compliance with the contract documents. The QAI randomly verified the welding parameters and surface temperatures utilizing a Fluke 337 Clamp Meter and a Tempilstik Temperature indicator.

See digital photographs below in regards to the work observed during this shift.
