Contract #: 04-0120F4Cty: SF/ALA Rte: 80 PM: 13.2/13.9File #: 1.28**WELDING INSPECTION REPORT****Resident Engineer:** Pursell, Gary**Address:** 333 Burma Road**City:** Oakland, CA 94607**Report No:** WIR-012310**Date Inspected:** 26-Feb-2010**Project Name:** SAS Superstructure**OSM Arrival Time:** 1500**Prime Contractor:** American Bridge/Fluor Enterprises, a JV**OSM Departure Time:** 2330**Contractor:** American Bridge/Fluor Enterprises, a JV**Location:** Job Site**CWI Name:** Bernie Docena**CWI Present:** Yes No**Inspected CWI report:** Yes No N/A**Rod Oven in Use:** Yes No N/A**Electrode to specification:** Yes No N/A**Weld Procedures Followed:** Yes No N/A**Qualified Welders:** Yes No N/A**Verified Joint Fit-up:** Yes No N/A**Approved Drawings:** Yes No N/A**Approved WPS:** Yes No N/A**Delayed / Cancelled:** Yes No N/A**Bridge No:** 34-0006**Component:** Segments 1E and 2E**Summary of Items Observed:**

Item 1: Field weld splice bottom plate.

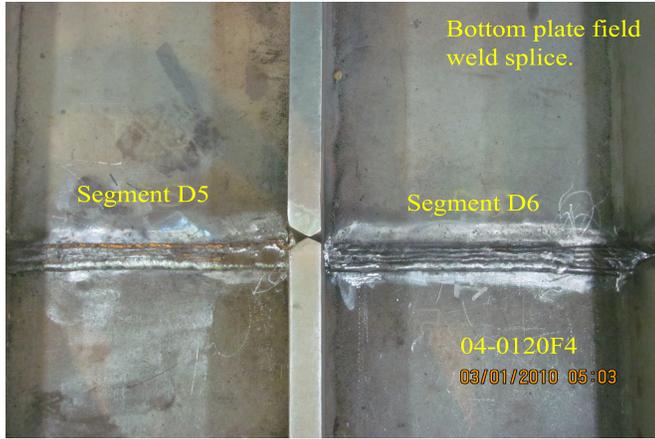
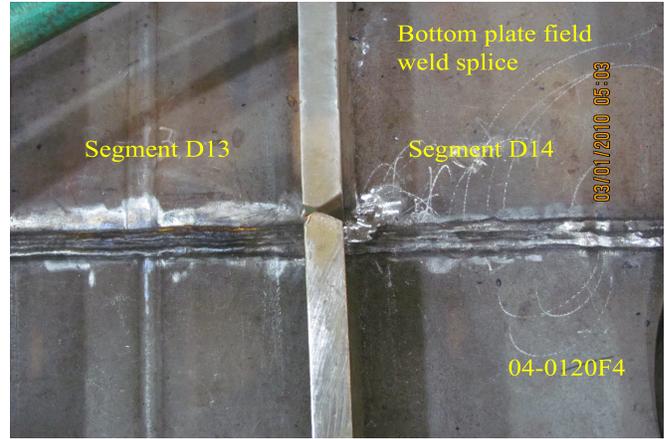
1. The (QA) inspector witnessed the post weld heat treatment on segments 1E-2E, D1 & D2 segments D5-6 and 14. The heat was maintained at 149°C for three hours. ABF (QC) Bernie Docena was also present during the observations.
