Contract #: 04-0120F4Cty: SF/ALA Rte: 80 PM: 13.2/13.9File #: 99.28**WELDING INSPECTION REPORT****Resident Engineer:** Pursell, Gary**Address:** 333 Burma Road**City:** Oakland, CA 94607**Report No:** WIR-012332**Date Inspected:** 26-Feb-2010**Project Name:** SAS Superstructure**OSM Arrival Time:** 645**Prime Contractor:** American Bridge/Fluor Enterprises, a JV**OSM Departure Time:** 1845**Contractor:** Zhenhua Port Machinery Company, Ltd (ZPMC) Chanxing Island **Location:** Shanghai, China**CWI Name:** Mr. Geng Wei**CWI Present:** Yes No**Inspected CWI report:** Yes No N/A**Rod Oven in Use:** Yes No N/A**Electrode to specification:** Yes No N/A**Weld Procedures Followed:** Yes No N/A**Qualified Welders:** Yes No N/A**Verified Joint Fit-up:** Yes No N/A**Approved Drawings:** Yes No N/A**Approved WPS:** Yes No N/A**Delayed / Cancelled:** Yes No N/A**Bridge No:** 34-0006**Component:** OBG Segment 9DW**Summary of Items Observed:**

WELDING INSPECTION REPORT

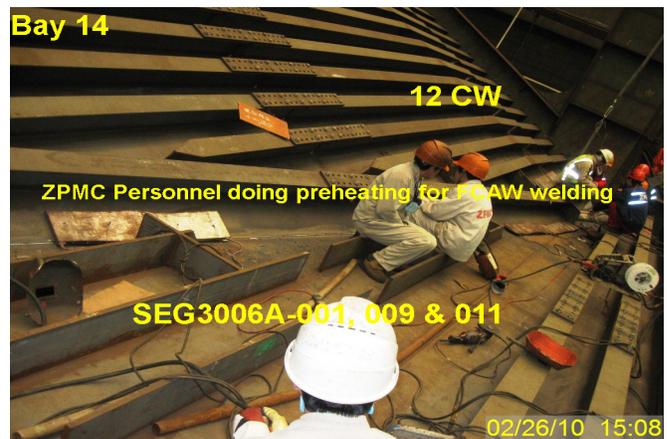
This QA inspector observed ZPMC qualified welding personnel identified as 202122 perform FCAW welding on Segment 12CW, weld joint identified as SEG3006A-011. ZPMC QC is identified as Mr. Xu Tao. The welding parameters as measured using QC's calibrated instruments appeared to be in general compliance with WPS-B-T-2231-B-U2-F. See the attached pictures.
