Contract #: 04-0120F4Cty: SF/ALA Rte: 80 PM: 13.2/13.9File #: 69.28**WELDING INSPECTION REPORT****Resident Engineer:** Pursell, Gary**Address:** 333 Burma Road**City:** Oakland, CA 94607**Report No:** WIR-012390**Date Inspected:** 06-Feb-2010**Project Name:** SAS Superstructure**OSM Arrival Time:** 645**Prime Contractor:** American Bridge/Fluor Enterprises, a JV**OSM Departure Time:** 1845**Contractor:** Zhenhua Port Machinery Company, Ltd (ZPMC), Changxing Island **Location:** Shanghai, China

West of Bay 19-

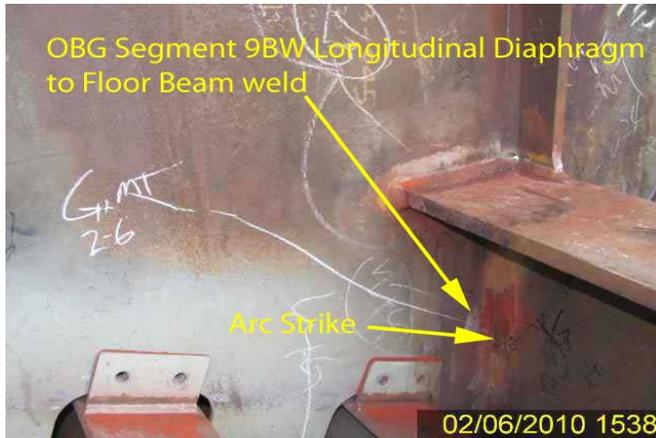
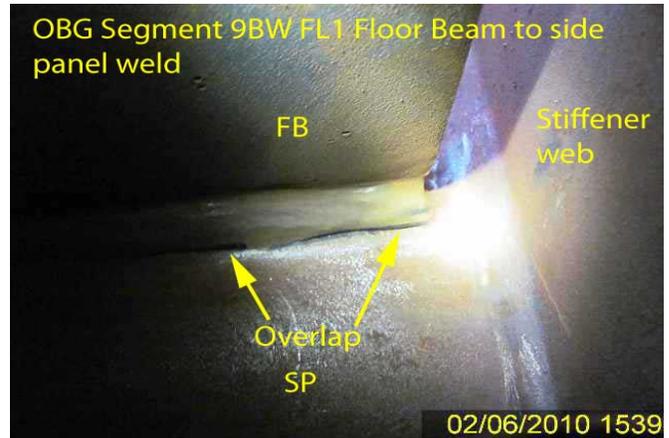
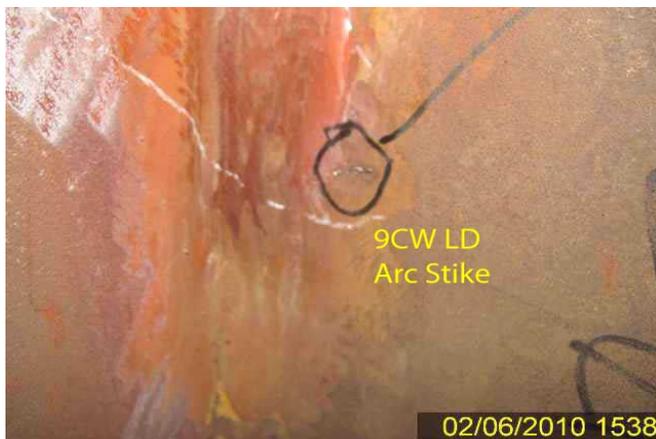
This QA Inspector performed random visual inspection of OBG segment 9BW internal weld surfaces. ZPMC and ABF QA have not visually accepted the above mentioned welds and repairs are still in process. Areas requiring light grinding were marked for ZPMC personnel. The location of areas requiring weld repair were marked on or adjacent the weld. Caltrans QA observed areas to include but not limited to overlap, arc strikes weld spatter and incomplete fusion areas. Please see attached photos below.
