Contract #: 04-0120F4Cty: SF/ALA Rte: 80 PM: 13.2/13.9File #: 69.28**WELDING INSPECTION REPORT****Resident Engineer:** Pursell, Gary**Address:** 333 Burma Road**City:** Oakland, CA 94607**Report No:** WIR-012507**Date Inspected:** 05-Feb-2010**Project Name:** SAS Superstructure**OSM Arrival Time:** 645**Prime Contractor:** American Bridge/Fluor Enterprises, a JV**OSM Departure Time:** 1845**Contractor:** Zhenhua Port Machinery Company, Ltd (ZPMC), Changxing Island **Location:** Shanghai, China**CWI Name:** Chen Xi**CWI Present:** Yes No**Inspected CWI report:** Yes No N/A**Rod Oven in Use:** Yes No N/A**Electrode to specification:** Yes No N/A**Weld Procedures Followed:** Yes No N/A**Qualified Welders:** Yes No N/A**Verified Joint Fit-up:** Yes No N/A**Approved Drawings:** Yes No N/A**Approved WPS:** Yes No N/A**Delayed / Cancelled:** Yes No N/A**Bridge No:** 34-0006**Component:** Orthotropic Box Girder (OBG)**Summary of Items Observed:**

OBG # CROSS BEAM CB04

OBG # CROSS BEAM CB15

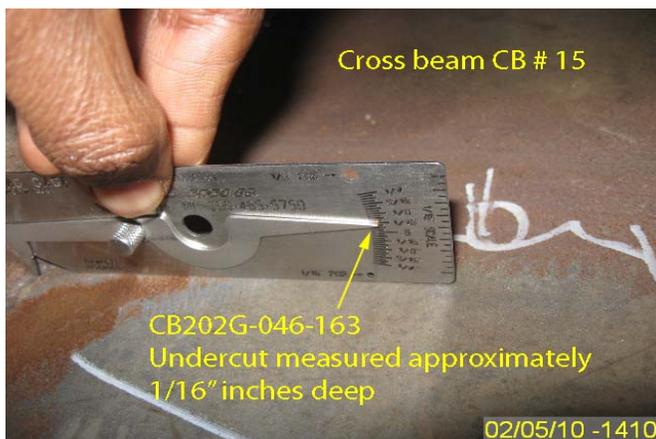
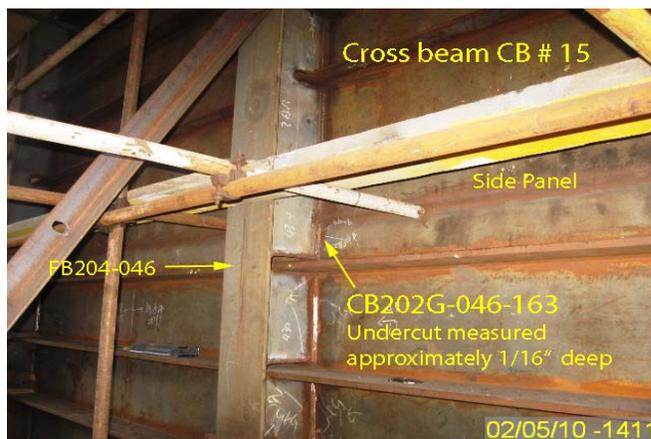
During random in process inspection of this crossbeam, this QA observed undercut in fillet weld identified as CB202G-046-163 measured approximately 1/16”(1.6mm)deep that do not appear to comply with the contract documents. Fabrication of this crossbeam is still in process and has not yet been released to QA for final inspection. See attached picture for more information.
