Contract #: 04-0120F4Cty: SF/ALA Rte: 80 PM: 13.2/13.9File #: 1.28**WELDING INSPECTION REPORT****Resident Engineer:** Pursell, Gary**Address:** 333 Burma Road**City:** Oakland, CA 94607**Report No:** WIR-012647**Date Inspected:** 15-Mar-2010**Project Name:** SAS Superstructure**OSM Arrival Time:** 630**Prime Contractor:** American Bridge/Fluor Enterprises, a JV**OSM Departure Time:** 1500**Contractor:** American Bridge/Fluor Enterprises, a JV**Location:** Job Site

## WELDING INSPECTION REPORT

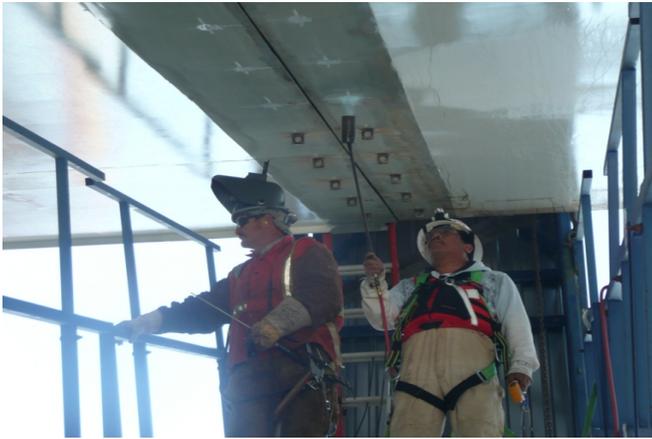
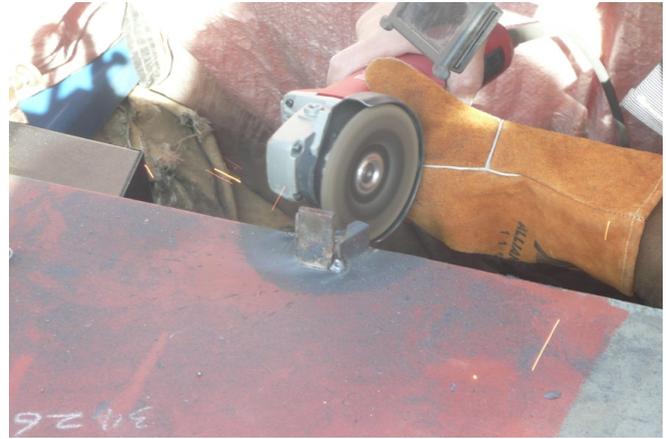
The QA Inspector noted the Smith Emery (SE) Quality Control (QC) Inspector Jesse Cayabayab on site to monitor and record the in process fit up. The QA Inspector randomly observed the QC Inspector performing dimensional measurements of the fit up as the ABF welding personnel performed the fit up tasks. The QA Inspector observed the ABF welder Rick Clayborn preheat and perform shielded metal arc welding (SMAW) of a fitting aid. The QA Inspector noted Mr. Clayborn was utilizing 1/8" E7018 low hydrogen electrodes with 151 Amps. The QA Inspector noted the SMAW parameters appeared to be in general compliance with ABF-WPS-D1.5-1200A. The QA Inspector observed Mr. Clayborn weld and attach the fitting aid to the side plate identified above. The QA Inspector observed after the temporary attachment was installed, Mr. Clayborn drove the pin or wedge through the

fitting aid to adjust the off set of the two members. The QA Inspector randomly observed the same process was repeated through the full length of the above identified weld joint. The QA Inspector randomly observed the SE QC Inspector Bnifacio Daquinag was on site to monitor the in process welding and fit up.
