DEPARTMENT OF TRANSPORTATION

Quality Assurance and Source Inspection

Contract #: 04-0120F4Cty: SF/ALA Rte: 80 PM: 13.2/13.9File #: 1.28**WELDING INSPECTION REPORT****Resident Engineer:** Pursell, Gary**Address:** 333 Burma Road**City:** Oakland, CA 94607**Report No:** WIR-012649**Date Inspected:** 17-Mar-2010**Project Name:** SAS Superstructure**OSM Arrival Time:** 1300**Prime Contractor:** American Bridge/Fluor Enterprises, a JV**OSM Departure Time:** 2130**Contractor:** American Bridge/Fluor Enterprises, a JV**Location:** Job Site**CWI Name:** T. Pasqualone/J. Cunningham**CWI Present:** Yes No**Inspected CWI report:** Yes No N/A**Rod Oven in Use:** Yes No N/A**Electrode to specification:** Yes No N/A**Weld Procedures Followed:** Yes No N/A**Qualified Welders:** Yes No N/A**Verified Joint Fit-up:** Yes No N/A**Approved Drawings:** Yes No N/A**Approved WPS:** Yes No N/A**Delayed / Cancelled:** Yes No N/A**Bridge No:** 34-0006**Component:** Orthotropic Box Girders**Summary of Items Observed:**

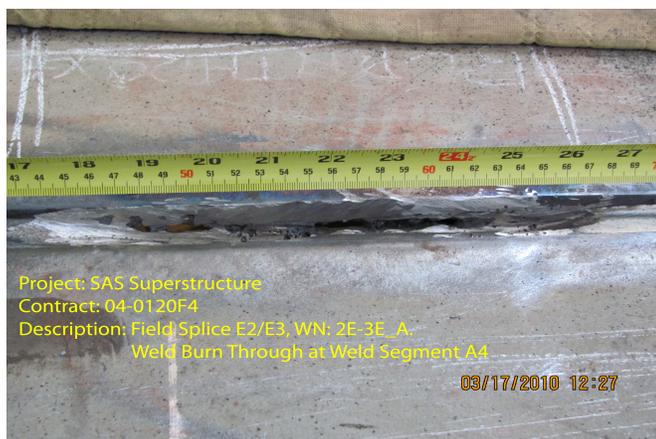
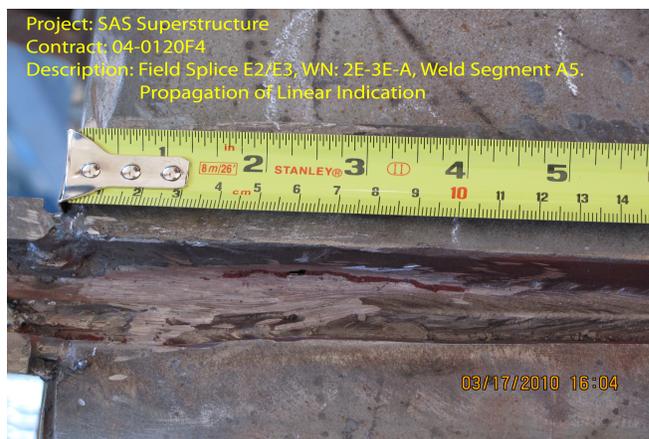
Later in the shift the QC inspector, Mr. Pasqualone, informed the QAI of a weld burn through that occurred during the SAW of the deck plate splice located approximately 44 cm south at the start of the A4 weld segment as indicated on the steel deck. The length of the weld burn through measured at 23 cm. The QAI visually observed the grinding of the area to a bright surface prior to the inspection and testing of the area. At this time the QC

The QAI also observed the excavation of the linear indication of the backing bar to deck plate weld. The excavation was performed by James Zhen utilizing a 4" grinder and at the conclusion of the grinding the QC inspector, Mr. Pasqualone performed an MPT of the excavation and at the conclusion of the testing the QC inspector noted the linear indication had propagated. Mr. Pasqualone contacted AB/F Welding Quality Control Manager (WQCM) James Bowers and at approximately 1700 Mr. Bowers arrived at the project location. Mr. Bowers observed the linear indication and a Weld Repair Procedure regarding the removal of the indication and the repair welding will be submitted for approval.

The digital photographs below illustrates the work observed during this scheduled shift.

inspector performed a visual inspection of the plate surface and at the conclusion of the inspection Mr. Pasqualone performed the Magnetic Particle Testing utilizing an AC/DC Parker Probe and at the conclusion of the testing no rejectable indications were noted. The repair welding was performed by Mr. Sittinger utilizing the Shielded Metal Arc Welding (SMAW) process as per the WPS ABF-WPS-D15-1000-1 Repair. The welding parameters were noted and verified by the QC inspector and were as follows, 124 amps. The repair area was ground to approximately the original shape of the detailed V-groove prior to the SAW. The repair of the burn through was completed during this scheduled shift.
