Contract #: 04-0120F4Cty: SF/ALA Rte: 80 PM: 13.2/13.9File #: 69.28**WELDING INSPECTION REPORT****Resident Engineer:** Pursell, Gary**Address:** 333 Burma Road**City:** Oakland, CA 94607**Report No:** WIR-012661**Date Inspected:** 18-Mar-2010**Project Name:** SAS Superstructure**OSM Arrival Time:** 700**Prime Contractor:** American Bridge/Fluor Enterprises, a JV**OSM Departure Time:** 1900**Contractor:** Zhenhua Port Machinery Company, Ltd (ZPMC), Changxing Island **Location:** Shanghai, China**CWI Name:** Li Yang**CWI Present:** Yes No**Inspected CWI report:** Yes No N/A**Rod Oven in Use:** Yes No N/A**Electrode to specification:** Yes No N/A**Weld Procedures Followed:** Yes No N/A**Qualified Welders:** Yes No N/A**Verified Joint Fit-up:** Yes No N/A**Approved Drawings:** Yes No N/A**Approved WPS:** Yes No N/A**Delayed / Cancelled:** Yes No N/A**Bridge No:** 34-0006**Component:** OBG**Summary of Items Observed:**

OBG SEGMENT 6 WEST

WELDING INSPECTION REPORT

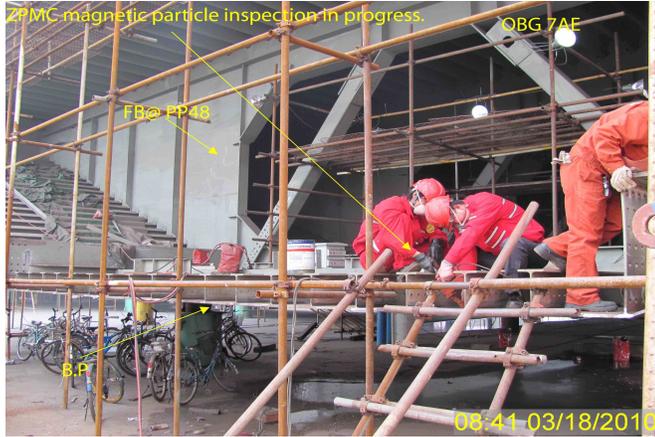
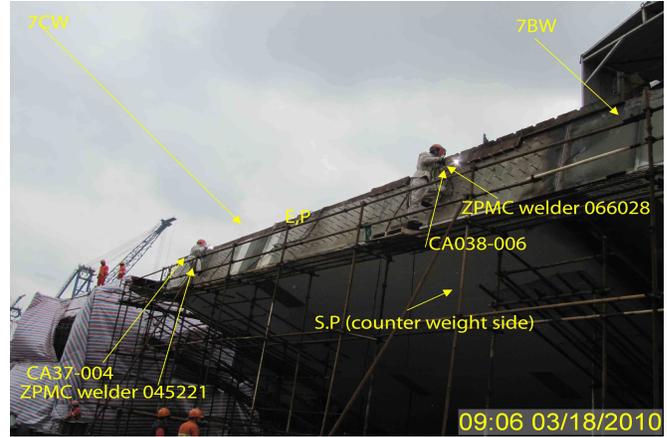
Unless otherwise noted, all work observed on this dated appeared to generally comply with applicable contract documents.
