DEPARTMENT OF TRANSPORTATION

Quality Assurance and Source Inspection

Contract #: 04-0120F4Cty: SF/ALA Rte: 80 PM: 13.2/13.9File #: 69.28**WELDING INSPECTION REPORT****Resident Engineer:** Pursell, Gary**Address:** 333 Burma Road**City:** Oakland, CA 94607**Report No:** WIR-012686**Date Inspected:** 15-Mar-2010**Project Name:** SAS Superstructure**OSM Arrival Time:** 700**Prime Contractor:** American Bridge/Fluor Enterprises, a JV**OSM Departure Time:** 1900**Contractor:** Zhenhua Port Machinery Company, Ltd (ZPMC), Changxing Island **Location:** Shanghai, China**CWI Name:** Li Yang**CWI Present:** Yes No**Inspected CWI report:** Yes No N/A**Rod Oven in Use:** Yes No N/A**Electrode to specification:** Yes No N/A**Weld Procedures Followed:** Yes No N/A**Qualified Welders:** Yes No N/A**Verified Joint Fit-up:** Yes No N/A**Approved Drawings:** Yes No N/A**Approved WPS:** Yes No N/A**Delayed / Cancelled:** Yes No N/A**Bridge No:** 34-0006**Component:** OBG**Summary of Items Observed:**

WELDING INSPECTION REPORT

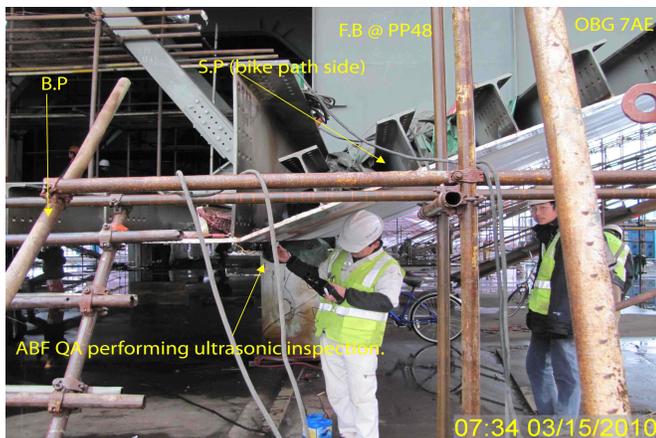
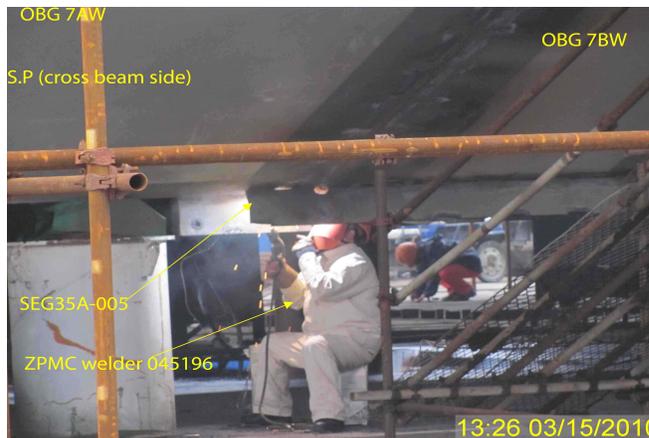
This Quality Assurance (QA) Inspector observed ZPMC qualified welder 045196 performing Shielded Metal Arc Welding process for weld SEG035A-005 located on PCMK weld between side panel and bottom panel (cross beam side). ZPMC QC Mr. Zhong Yang Gang monitoring this welding. The welding variables recorded by QC appeared to comply with the WPS-345-SMAW-4G (4F)-FCM-Repair-1. Weld repair report identified as B-WR10620.

This Quality Assurance (QA) Inspector observed ZPMC personnel performing carbon air arc gouging on the weld between edge panel and deck panel (bike path side).

This Quality Assurance (QA) Inspector observed ZPMC personnel performing sand blasting in OBG segment 6AE at FL -003 locations near the PP38, 39, 40.

This Quality Assurance (QA) Inspector observed ABF QA Inspector performing ultrasonic inspection for the weld between side panel and bottom panel (bike path side) in OBG segment 7AE near the PP48.
