Contract #: 04-0120F4Cty: SF/ALA Rte: 80 PM: 13.2/13.9File #: 69.28**WELDING INSPECTION REPORT****Resident Engineer:** Pursell, Gary**Address:** 333 Burma Road**City:** Oakland, CA 94607**Report No:** WIR-012752**Date Inspected:** 14-Mar-2010**Project Name:** SAS Superstructure**OSM Arrival Time:** 700**Prime Contractor:** American Bridge/Fluor Enterprises, a JV**OSM Departure Time:** 1900**Contractor:** Zhenhua Port Machinery Company, Ltd (ZPMC), Changxing Island **Location:** Shanghai, China**CWI Name:** Mr. Yu Dong Ping**CWI Present:** Yes No**Inspected CWI report:** Yes No N/A**Rod Oven in Use:** Yes No N/A**Electrode to specification:** Yes No N/A**Weld Procedures Followed:** Yes No N/A**Qualified Welders:** Yes No N/A**Verified Joint Fit-up:** Yes No N/A**Approved Drawings:** Yes No N/A**Approved WPS:** Yes No N/A**Delayed / Cancelled:** Yes No N/A**Bridge No:** 34-0006**Component:** Tower**Summary of Items Observed:**

WELDING INSPECTION REPORT

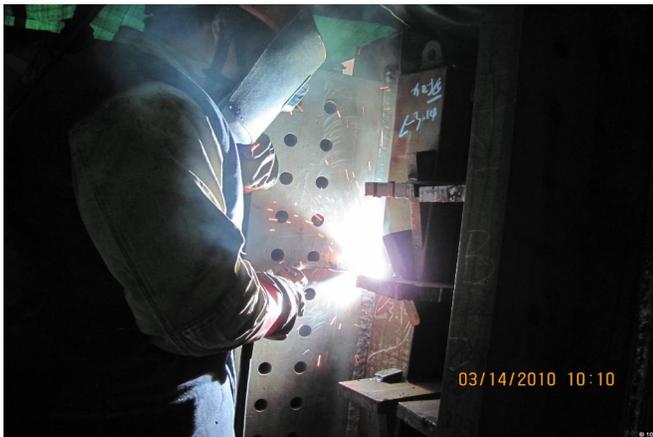
1. This QA inspector, Baskar Govindarajan, observed, ZPMC qualified welding personnel identified as 040155, 041271 perform SMAW welding on, CD corner of West tower, Lift 5, and weld joint identified as WSD1-TL5-4B/F- 2A, 38B. ZPMC CWI Identified as Mr. Xu le feng. The welding parameters as measured using QC's calibrated instruments appeared to be in general compliance with WPS-B-T-3211-U4B-1. (Photo attached)

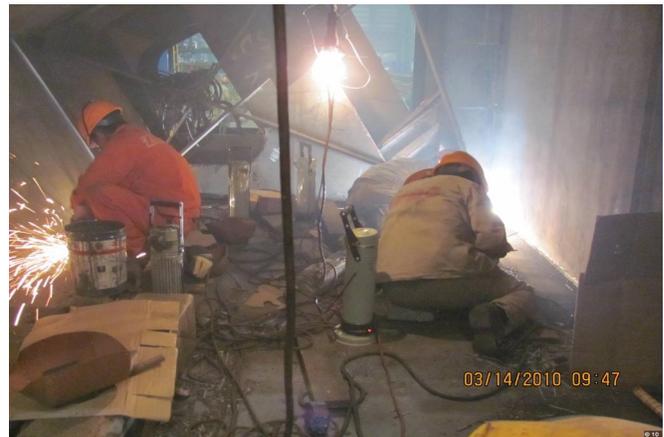
4.This QA inspector, Baskar Govindarajan, observed, ZPMC qualified welding personnel identified as 040704, 040609 perform FCAW welding on, Exterior Bearing stiffener of West tower, Lift 1, Skin B, and weld joint identified as WSD1-SA279-22, 18 and 34. ZPMC CWI Identified as Mr. Ye yong Jun. The welding parameters as measured using QC's calibrated instruments appeared to be in general compliance with WPS-B-T-2333-TC-P4-F. (Photo attached)
