Quality Assurance and Source Inspection

Contract #: 04-0120F4Cty: SF/ALA Rte: 80 PM: 13.2/13.9File #: 1.28**WELDING INSPECTION REPORT****Resident Engineer:** Pursell, Gary**Address:** 333 Burma Road**City:** Oakland, CA 94607**Report No:** WIR-012771**Date Inspected:** 24-Mar-2010**Project Name:** SAS Superstructure**OSM Arrival Time:** 1300**Prime Contractor:** American Bridge/Fluor Enterprises, a JV**OSM Departure Time:** 2130**Contractor:** American Bridge/Fluor Enterprises, a JV**Location:** Job Site**CWI Name:** See Contents in Report**CWI Present:** Yes No**Inspected CWI report:** Yes No N/A**Rod Oven in Use:** Yes No N/A**Electrode to specification:** Yes No N/A**Weld Procedures Followed:** Yes No N/A**Qualified Welders:** Yes No N/A**Verified Joint Fit-up:** Yes No N/A**Approved Drawings:** Yes No N/A**Approved WPS:** Yes No N/A**Delayed / Cancelled:** Yes No N/A**Bridge No:** 34-0006**Component:** Orthotropic Box Girders**Summary of Items Observed:**

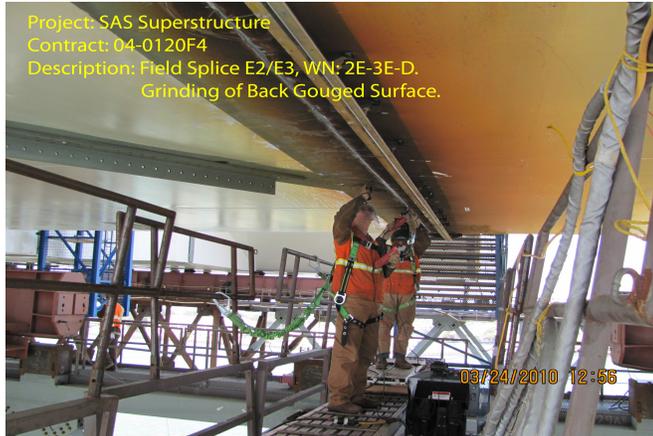
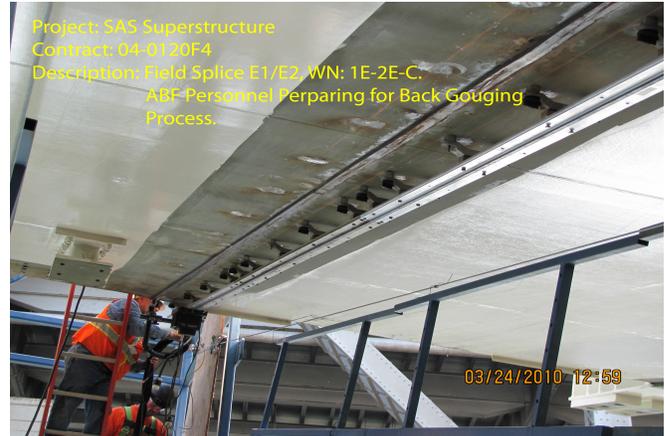
The QAI observed the Complete Joint Penetration (CJP) groove welding of the edge plate field splice identified as Weld Number (WN): 2E-3E-B, Segment B1. The welding was performed by the AB/F personnel Songtao Huang ID-3794, utilizing the Flux Cored Arc Welding (FCAW-G) process, with the welding progression in the vertical up position (3G), as per the Welding Procedure Specification (WPS) ABF-WPS-D15-3042B-3 Rev. 0 and the AWS D1.5-2002 Chapter 5/Section 5.12. The WPS was also used by the AB/F Quality Control (QC) Inspector Mr. Cunningham as a reference to perform QC verification of the Direct Current Electrode Positive (DCEP) welding parameters during the CJP groove welding of the edge plate field splice. The QAI also observed the QC inspector verifying the welding parameters and were noted as follows: 218 amps, 22.8 volts and a travel speed measured at 152 mm/minute. The QC inspector also monitored the surface temperatures during the field welding and the following was observed and noted by the QAI: the minimum preheat temperature of 60 degrees Celsius and the maximum interpass temperature of 230 degrees Celsius. The CJP welding was completed during this shift.

The QAI observed the automated FCAW-G welding process during the CJP welding of the bottom plate field splice performed by Rory Hogan ID-3186 and Jeremy Dolman ID-5042. The welders utilized the FCAW-G welding process as per the WPS ABF-WPS-D15-3040A-4 Rev. 0 which was also used as a reference by the QC inspector Bernie Docena to verify the welding parameters and the surface temperatures. The DCEP welding parameters were verified and noted by the QC inspector and were noted as follows: 256 amps, 23 volts and a travel speed measured at 190mm/minute. The minimum preheat temperature of 65 degrees Celsius and the maximum interpass temperature of 230 degrees Celsius were maintained. The welding operators appeared to be experiencing areas of porosity during the CJP welding which required additional grinding prior to welding of subsequent passes. The welding was terminated at approximately 1715 and the contractor, AB/F, has elected to leave the heating bands on the weld joint continuously which was verified by the QAI, at the time the welding was terminated, and will resume welding on the next scheduled shift, 03/25/10.

The QAI performed a survey of the backing bars located at the field splices E1/E2 and E2/E3 identified accordingly as WN: 1E-2E-A and 2E-3E-A. There appeared to be weld burn through at various locations along the backing bar. The QAI also observed a misalignment of the E3/E4 deck plate field splice identified as WN: 3E-4E-A. The QAI has generated a TL-15 Report for each of the issues at hand.

The digital photographs on page 3 of this report illustrates the work observed during this scheduled shift.
