Contract #: 04-0120F4Cty: SF/ALA Rte: 80 PM: 13.2/13.9File #: 13.28**WELDING INSPECTION REPORT****Resident Engineer:** Pursell, Gary**Address:** 333 Burma Road**City:** Oakland, CA 94607**Report No:** WIR-012796**Date Inspected:** 23-Mar-2010**Project Name:** SAS Superstructure**OSM Arrival Time:** 1000**Prime Contractor:** American Bridge/Fluor Enterprises, a JV**OSM Departure Time:** 1830**Contractor:** Oregon Iron Works Clackamas, Or.**Location:** Clackamas, OR

| <b>Bridge No:</b> | 34-0006 | <b>Component:</b> | Hinge K Pipe Beams | |

**Hinge-K Pipe Beam Assembly 102A-2:**

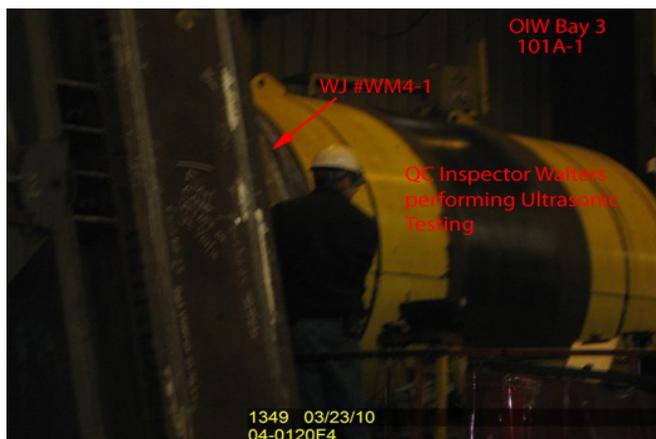
The QA Inspector witnessed OIW QC Inspector Rob Walters performing Ultrasonic Testing (UT) on the previously completed submerged arc welding (SAW) joint, # WM4-1. The QA Inspector noted that this was a Complete Joint Penetration (CJP), AWS D1.5 B-U7-S, piece mark Fuse 120A-1 to Forging 102A-1. QC Inspector Walters explained that he was currently performing the straight beam ultrasonic testing for laminar reflectors, per AWS D1.5 and that he had previously performed a calibration on the straight beam search unit. QC Inspector Walters later explained that the straight beam testing had been performed and completed on the entire base metal area that the weld will be tested and no rejectable indications were found. QC Inspector Walters explained that he was currently setting up for calibration, in preparation for the angle beam ultrasonic testing of the weld, with a 60 degree Lucite wedge coupled to a 2.25 MHz frequency transducer. See attached picture below.
