DEPARTMENT OF TRANSPORTATION

Contract #: 04-0120F4Cty: SF/ALA Rte: 80 PM: 13.2/13.9File #: 1x.28**WELDING INSPECTION REPORT****Resident Engineer:** Pursell, Gary**Address:** 333 Burma Road**City:** Oakland, CA 94607**Report No:** WIR-012801**Date Inspected:** 24-Mar-2010**Project Name:** SAS Superstructure**OSM Arrival Time:** 630**Prime Contractor:** American Bridge/Fluor Enterprises, a JV**OSM Departure Time:** 1500**Contractor:** American Bridge/Fluor Enterprises, a JV**Location:** Job Site

WELDING INSPECTION REPORT

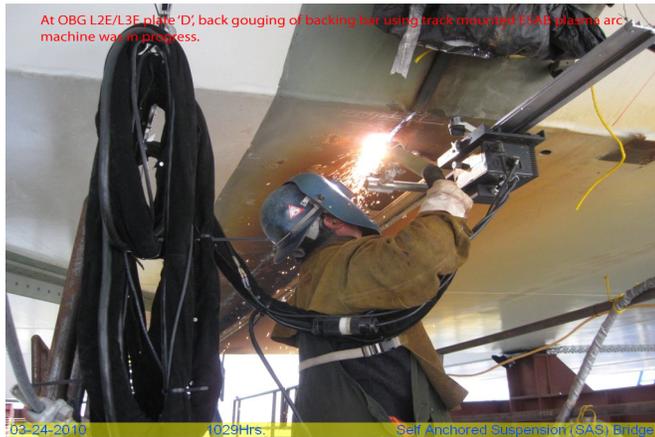
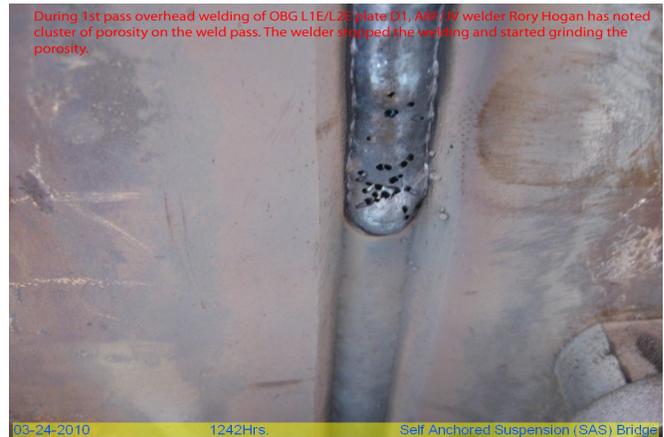
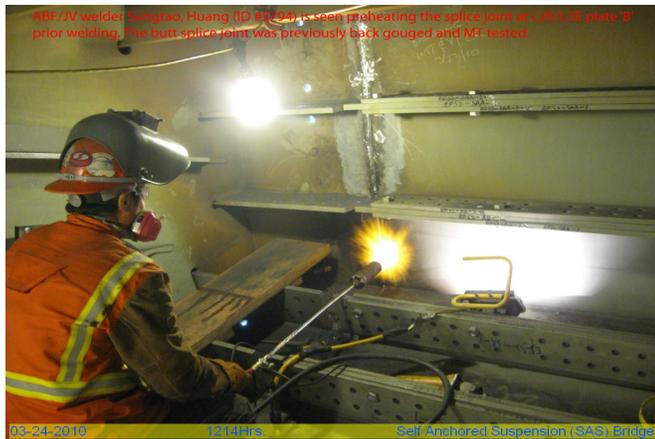
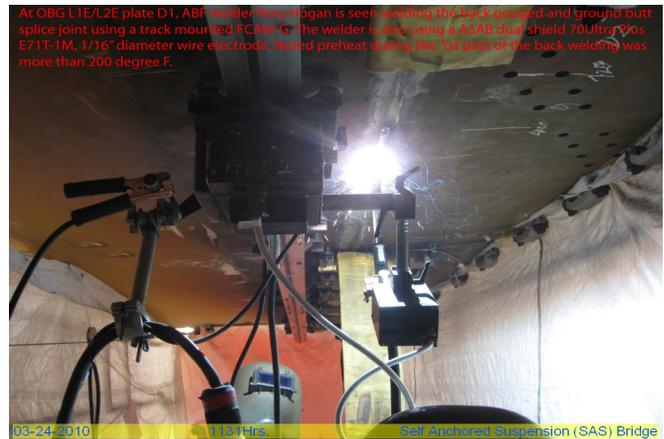
QA randomly observed ABF/JV qualified welders Rory Hogan (ID #3186) and Jeremy Dolman perform CJP groove (splice) welding fill 1st pass on Orthotropic Box Girder (OBG) L1E/L2E plate 'D'. The welders were observed welding in the 4G (overhead) position utilizing a dual shield Flux Cored Arc Welding (FCAW-G) with E71T-1M, 1/16" diameter wire electrode and implementing Caltrans approved Welding Procedure Specification (WPS) ABF-WPS-D15-3040A-4. The welder was using a track mounted welder holder assembly that is remotely controlled. The joint being welded has the backing bar gouged using the Esab Plasma Arc machine and was ground smooth. The splice joint was preheated to greater than 200 degree Fahrenheit prior welding and the vicinity was properly protected from wind. During welding, ABF Quality Control (QC) Bernie Docena was noted monitoring the welding parameters of the welder. The parameter readings taken during welding were 262 amperes, 22.8 volts with travel speed of 180 mm per minute travel speed which are deemed acceptable to contract specifications. The 1st pass that the welder completed was generally good except for two areas that have cluster porosity. As soon as the welder noted the porosity, he stopped welding and informed the QC. QA was informed by QC that he instructed the welder to grind remove the affected areas.

At OBG L2E/L3E plate 'B', QA randomly observed ABF/JV qualified welder Sungtao, Huang ID # 3794 perform CJP groove (splice) welding fill pass. The welder was observed manually welding in the 3G (vertical) position utilizing a dual shield Flux Cored Arc Welding (FCAW-G) with E71T-1M, 1/16" diameter wire electrode and

implementing Caltrans approved Welding Procedure Specification (WPS) ABF-WPS-D15-3040B-3. The joint being welded has the backing bar gouged using the Esab Plasma Arc machine and was ground smooth. The splice joint was preheated to greater than 150 degree Fahrenheit prior welding. During welding, ABF Quality Control (QC) Jim Cunningham was noted monitoring the welding parameters of the welder. The parameter readings taken during welding were 218 amperes, 22.8 volts which are deemed acceptable to contract specifications.

QAI also randomly observed ABF personnel perform back gouging of backing bar at OBG L2E/L3E plate 'D' using a track mounted Esab plasma arc machine. After completing the gouging of the backing bar, the depth of the groove of the splice butt joint (after the plasma arc gouging) was measured greater than 5.0mm. ABF personnel were noted grinding the gouged groove joint after gouging.
