**DEPARTMENT OF TRANSPORTATION**

Contract #: 04-0120F4Cty: SF/ALA Rte: 80 PM: 13.2/13.9File #: 1x.28**WELDING INSPECTION REPORT****Resident Engineer:** Pursell, Gary**Address:** 333 Burma Road**City:** Oakland, CA 94607**Report No:** WIR-012816**Date Inspected:** 29-Mar-2010**Project Name:** SAS Superstructure**OSM Arrival Time:** 1100**Prime Contractor:** American Bridge/Fluor Enterprises, a JV**OSM Departure Time:** 1930**Contractor:** American Bridge/Fluor Enterprises, a JV**Location:** Job Site

# WELDING INSPECTION REPORT

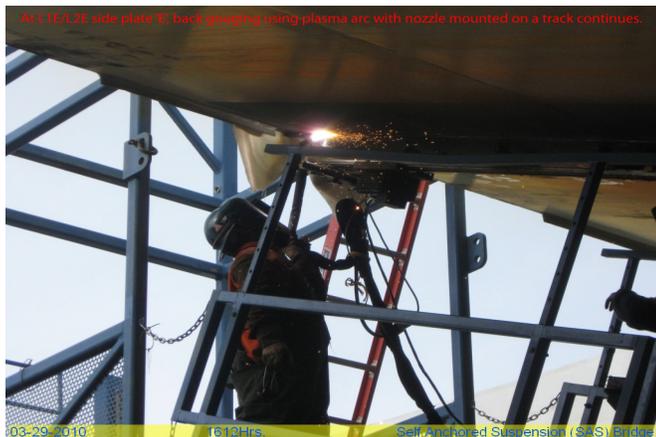
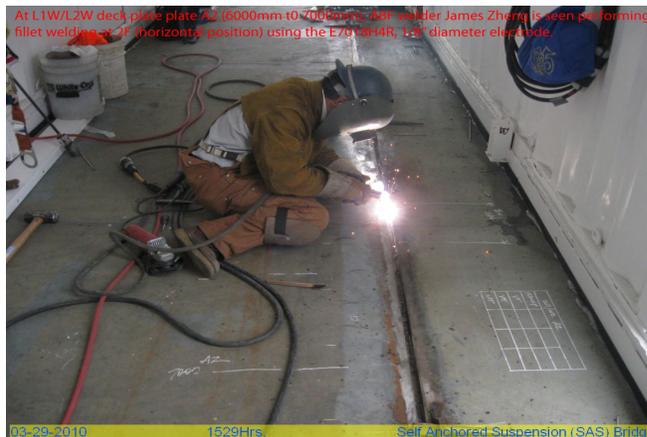
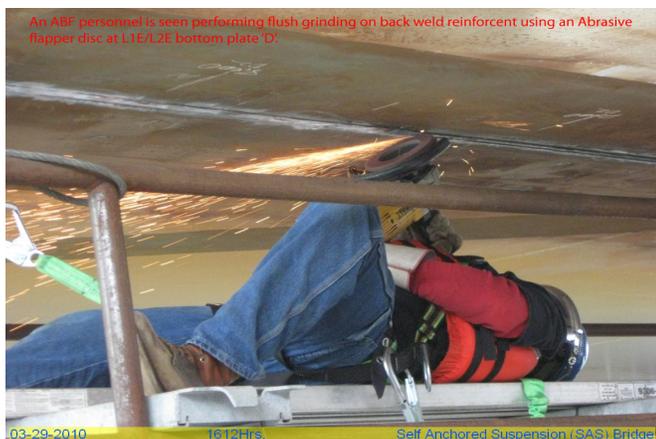
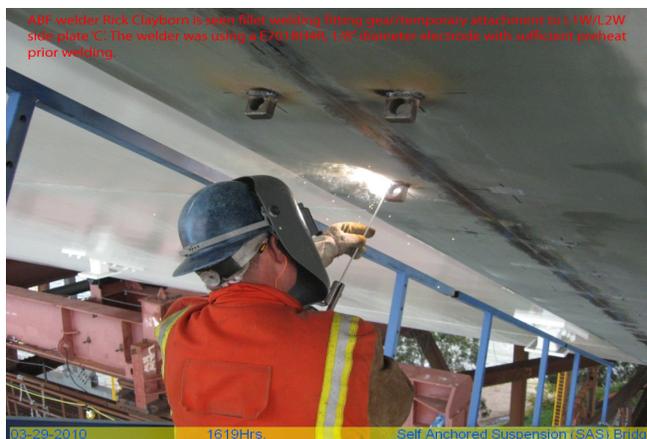
QAI had noted ABF/JV welder James Zheng (I.D. 6001) performed the horizontal (2F) fillet welding of the backing bar to one side of the deck plate at Orthotropic Box Girder (OBG) L1W/L2W deck plate 'A'. The welder was using shielded metal arc welding (SMAW) with 1/8" E7018 H4R electrode implementing Welding Procedure Specification (WPS) ABF-WPS-D15-F1200A. During welding, the welder was noted preheating the plates prior welding and ABF QC Jesus Cayabyab was noted monitoring the welding parameters.

At OBG L1W/L2W plate 'C', ABF/JV welder Rick Clayborn (I.D. 2773) performed the overhead (4F) fillet welding of the temporary attachment fitting gear to side plate 'C' that will hold the backing bar to the splice butt joint welding. The welder was using shielded metal arc welding (SMAW) with 1/8" E7018 H4R electrode implementing Welding Procedure Specification (WPS) ABF-WPS-D15-F1200A. During welding, the welder was noted preheating the plates prior welding and ABF QC Bonifacio Daquinag was also noted monitoring the welding parameters.

At OBG L2E/L3E bottom plate 'D', ABF QC Jim Cunningham was observed performing Magnetic Particle Testing on the back gouged and ground backing bar removal. The QC was noted using a Magnaflux electromagnetic yoke with red magnetic powder as detecting media. Two ABF personnel were also noted grinding areas that QC has found with MT indications.

QAI also noted ABF personnel perform gouging of backing bar at L1E/L2E plate 'E' using the track mounted plasma arc machine. Also at OBG L1E/L2E bottom plate 'D', two ABF personnel were noted flush grinding the back weld reinforcement using abrasive flapper discs. Both jobs are still continuing.
