**DEPARTMENT OF TRANSPORTATION**

Contract #: 04-0120F4Cty: SF/ALA Rte: 80 PM: 13.2/13.9File #: 69.28**WELDING INSPECTION REPORT****Resident Engineer:** Pursell, Gary**Address:** 333 Burma Road**City:** Oakland, CA 94607**Report No:** WIR-012831**Date Inspected:** 19-Mar-2010**Project Name:** SAS Superstructure**OSM Arrival Time:** 1900**Prime Contractor:** American Bridge/Fluor Enterprises, a JV**OSM Departure Time:** 700**Contractor:** Zhenhua Port Machinery Company, Ltd (ZPMC), Changxing Island **Location:** Shanghai, China**CWI Name:** See Below**CWI Present:** Yes No**Inspected CWI report:** Yes No N/A**Rod Oven in Use:** Yes No N/A**Electrode to specification:** Yes No N/A**Weld Procedures Followed:** Yes No N/A**Qualified Welders:** Yes No N/A**Verified Joint Fit-up:** Yes No N/A**Approved Drawings:** Yes No N/A**Approved WPS:** Yes No N/A**Delayed / Cancelled:** Yes No N/A**Bridge No:** 34-0006**Component:** OBG**Summary of Items Observed:**

**OBG BAY 6**

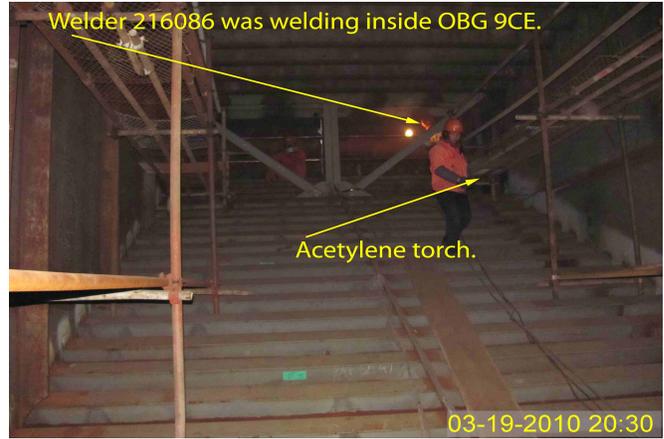
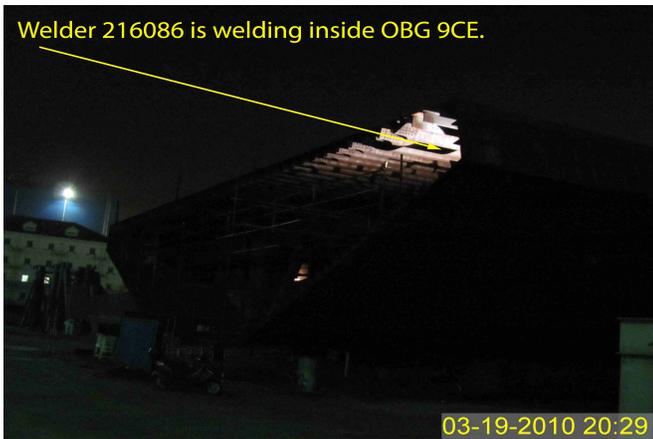
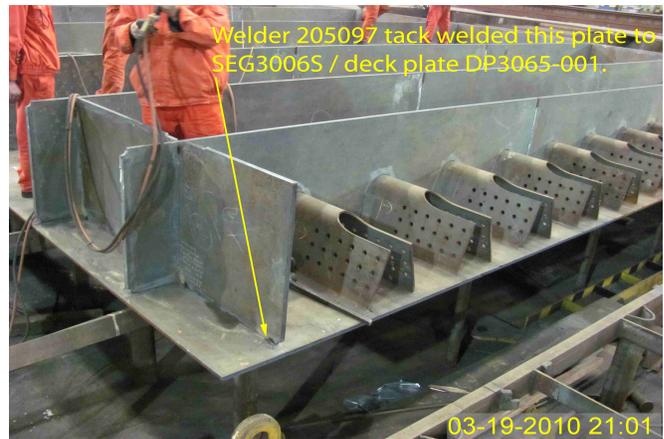
This QA Inspector observed ZPMC welder Mr. Wang Zhenbing, stencil 216086 is using the shielded metal arc welding process to perform various weld repairs to OBG segment 9CE, panel point 77, corner assembly stiffener plate welds. During the past several weeks this QA Inspector has observed no ZPMC personnel appear to have been performing welding near this location and no ZPMC QC personnel appear to be assigned to monitor activities in this location. As this QA Inspector walked toward this OBG segment one of the workers appeared to alert ZPMC welder Mr. Wang Zhenbing that this QA Inspector was near this segment and Mr. Wang Zhenbing stopped welding. Mr. Wang Zhenbing appears to be certified to make this weld and a second worker was holding an acetylene torch near where this welding had taken place. This QA Inspector monitored this general location for approximately thirty minutes and Mr. Wang Zhenbing did not appear to perform any additional welding and no ZPMC QC welding Inspectors were observed to be near this location. See the photographs below for additional information.
