Contract #: 04-0120F4Cty: SF/ALA Rte: 80 PM: 13.2/13.9File #: 69.28**WELDING INSPECTION REPORT****Resident Engineer:** Pursell, Gary**Address:** 333 Burma Road**City:** Oakland, CA 94607**Report No:** WIR-012865**Date Inspected:** 05-Apr-2010**Project Name:** SAS Superstructure**OSM Arrival Time:** 700**Prime Contractor:** American Bridge/Fluor Enterprises, a JV**OSM Departure Time:** 1900**Contractor:** Zhenhua Port Machinery Company, Ltd (ZPMC), Changxing Island **Location:** Shanghai, China**CWI Name:** Li Yun Hua**CWI Present:** Yes No**Inspected CWI report:** Yes No N/A**Rod Oven in Use:** Yes No N/A**Electrode to specification:** Yes No N/A**Weld Procedures Followed:** Yes No N/A**Qualified Welders:** Yes No N/A**Verified Joint Fit-up:** Yes No N/A**Approved Drawings:** Yes No N/A**Approved WPS:** Yes No N/A**Delayed / Cancelled:** Yes No N/A**Bridge No:** 34-0006**Component:** OBG**Summary of Items Observed:**

WELDING INSPECTION REPORT

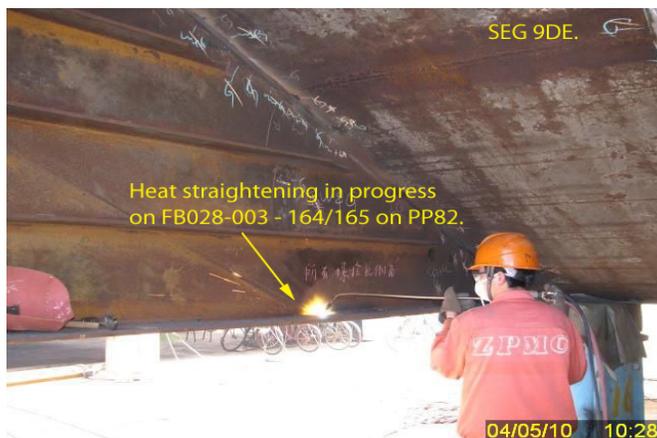
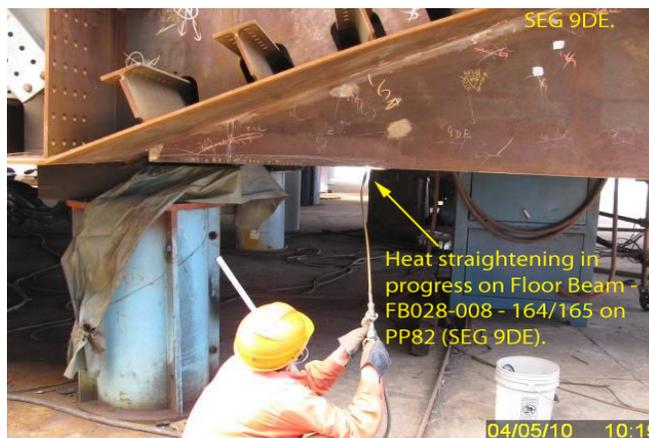
This QA Inspector observed ZPMC personnel performing heat straightening of weld no: FB028-003 – 164/165, Floor Beam on PP 82 of OBG SEG 9DE. This QA Inspector verified the heat straightening report (HSR) no: 8257. ZPMC Quality Control (QC) is identified as Li Ping.

For details, refer attached photos.
