Contract #: 04-0120F4Cty: SF/ALA Rte: 80 PM: 13.2/13.9File #: 69.28**WELDING INSPECTION REPORT****Resident Engineer:** Pursell, Gary**Address:** 333 Burma Road**City:** Oakland, CA 94607**Report No:** WIR-012866**Date Inspected:** 31-Mar-2010**Project Name:** SAS Superstructure**OSM Arrival Time:** 700**Prime Contractor:** American Bridge/Fluor Enterprises, a JV**OSM Departure Time:** 1900**Contractor:** Zhenhua Port Machinery Company, Ltd (ZPMC), Changxing Island **Location:** Shanghai, China**CWI Name:** Chen Xi.**CWI Present:** Yes No**Inspected CWI report:** Yes No N/A**Rod Oven in Use:** Yes No N/A**Electrode to specification:** Yes No N/A**Weld Procedures Followed:** Yes No N/A**Qualified Welders:** Yes No N/A**Verified Joint Fit-up:** Yes No N/A**Approved Drawings:** Yes No N/A**Approved WPS:** Yes No N/A**Delayed / Cancelled:** Yes No N/A**Bridge No:** 34-0006**Component:** OBG.**Summary of Items Observed:**

WELDING INSPECTION REPORT

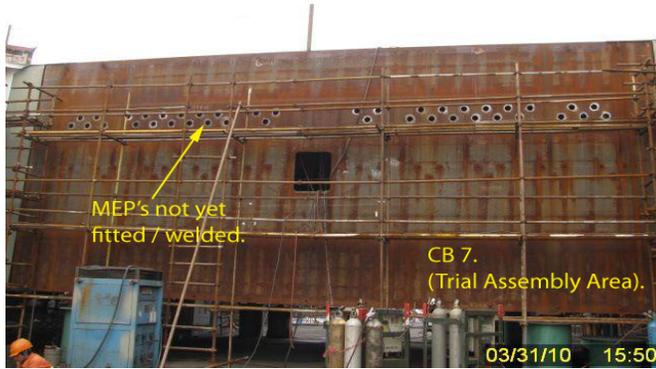
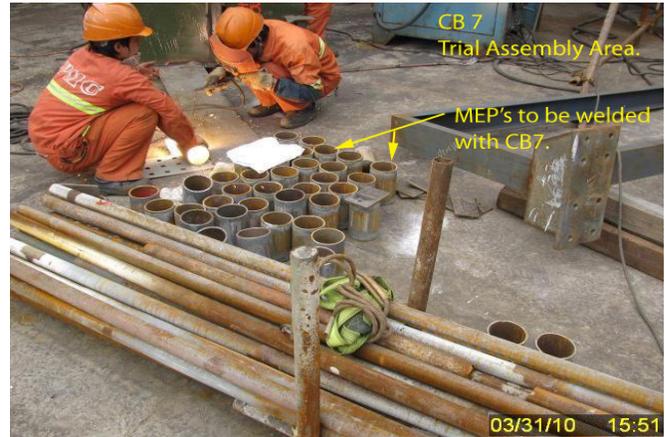
The above mentioned notification also included NDT (MT – TAG#9) of fillet welds of MEP's. However, this QA Inspector observed that these MEP's were not even fitted with CB. ZPMC QC identified as Mr. Tian Lei & QA identified as Mr. Zhong Wei were then informed about this.

Refer attached photos for further information.
