DEPARTMENT OF TRANSPORTATION

Quality Assurance and Source Inspection

Contract #: 04-0120F4Cty: SF/ALA Rte: 80 PM: 13.2/13.9File #: 69.28**WELDING INSPECTION REPORT****Resident Engineer:** Pursell, Gary**Address:** 333 Burma Road**City:** Oakland, CA 94607**Report No:** WIR-012897**Date Inspected:** 20-Mar-2010**Project Name:** SAS Superstructure**OSM Arrival Time:** 700**Prime Contractor:** American Bridge/Fluor Enterprises, a JV**OSM Departure Time:** 1900**Contractor:** Zhenhua Port Machinery Company, Ltd (ZPMC), Changxing Island **Location:** Shanghai, China**CWI Name:** Mr. Yu Dong Ping**CWI Present:** Yes No**Inspected CWI report:** Yes No N/A**Rod Oven in Use:** Yes No N/A**Electrode to specification:** Yes No N/A**Weld Procedures Followed:** Yes No N/A**Qualified Welders:** Yes No N/A**Verified Joint Fit-up:** Yes No N/A**Approved Drawings:** Yes No N/A**Approved WPS:** Yes No N/A**Delayed / Cancelled:** Yes No N/A**Bridge No:** 34-0006**Component:** Tower**Summary of Items Observed:**

WELDING INSPECTION REPORT

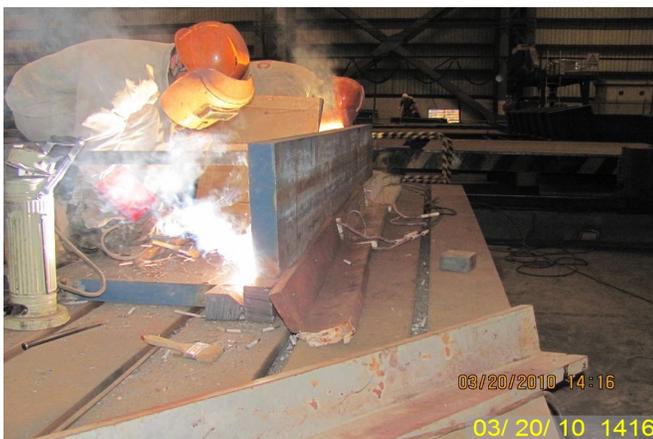
3. This QA inspector, Baskar Govindarajan, observed, ZPMC qualified welding personnel identified as 040614 perform SMAW welding on, Strut splice plate, and weld joint identified as SD1-SA4-56-143mtr.-1,2,3,4- 1A. ZPMC CWI Identified as Mr. Yu Dong Ping. The welding parameters as measured using QC's calibrated instruments appeared to be in general compliance with WPS-B-T-3221-TC-U5B-1. (Photo attached)

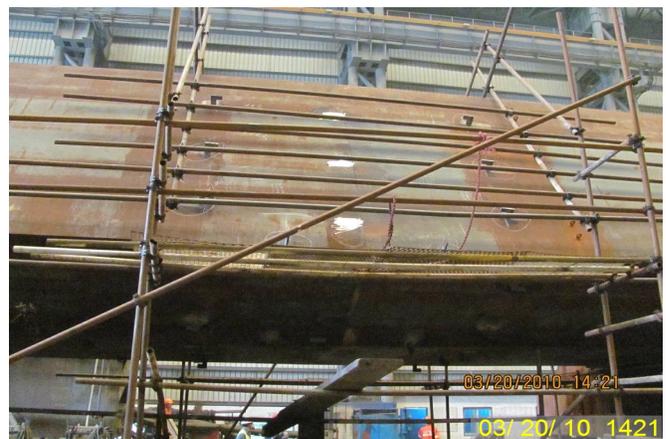
4.This QA inspector, Baskar Govindarajan, has taken exterior alignment reading between East tower lift 3 and Lift 4 at Bay no. 11 on all skins. i.e. Skin A, B, C, D and E. The reading was taken along with Caltrans Inspector Mr. Sandeep Kumar, B 227, and the reading found to be within + or -2 mm.The maximum misalignment have observed on Skin B. This was reported to SMR. (Photo of Lift 3 and 4 attached)
