**DEPARTMENT OF TRANSPORTATION**

Contract #: 04-0120F4Cty: SF/ALA Rte: 80 PM: 13.2/13.9File #: 69.28**WELDING INSPECTION REPORT****Resident Engineer:** Pursell, Gary**Address:** 333 Burma Road**City:** Oakland, CA 94607**Report No:** WIR-012901**Date Inspected:** 25-Mar-2010**Project Name:** SAS Superstructure**OSM Arrival Time:** 700**Prime Contractor:** American Bridge/Fluor Enterprises, a JV**OSM Departure Time:** 1900**Contractor:** Zhenhua Port Machinery Company, Ltd (ZPMC), Changxing Island **Location:** Shanghai, China**CWI Name:** Mr. Yu Dong Ping**CWI Present:** Yes No**Inspected CWI report:** Yes No N/A**Rod Oven in Use:** Yes No N/A**Electrode to specification:** Yes No N/A**Weld Procedures Followed:** Yes No N/A**Qualified Welders:** Yes No N/A**Verified Joint Fit-up:** Yes No N/A**Approved Drawings:** Yes No N/A**Approved WPS:** Yes No N/A**Delayed / Cancelled:** Yes No N/A**Bridge No:** 34-0006**Component:** Tower**Summary of Items Observed:**

# WELDING INSPECTION REPORT

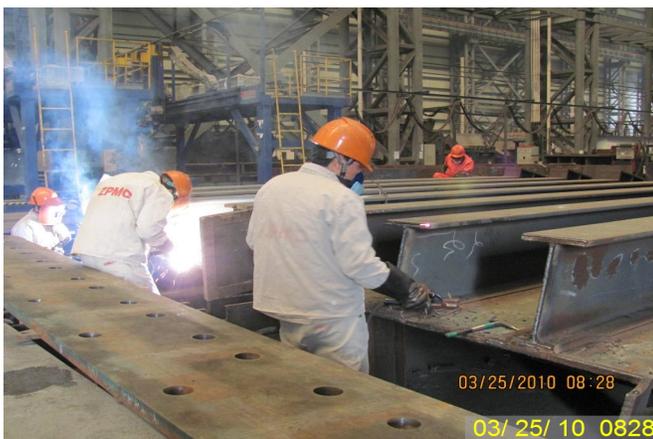
1. This QA inspector, Baskar Govindarajan, observed, ZPMC qualified welding personnel identified as 040733, 049099 perform SMAW Buttering welding on, Skirt plate, and Skirt plate identified as WSD1-A 804. ZPMC CWI Identified as Mr. An Qing Xiang. The welding parameters as measured using QC's calibrated instruments appeared to be in general compliance with WPS-345-SMAW-2G (2F)-Repair. (Photo attached)

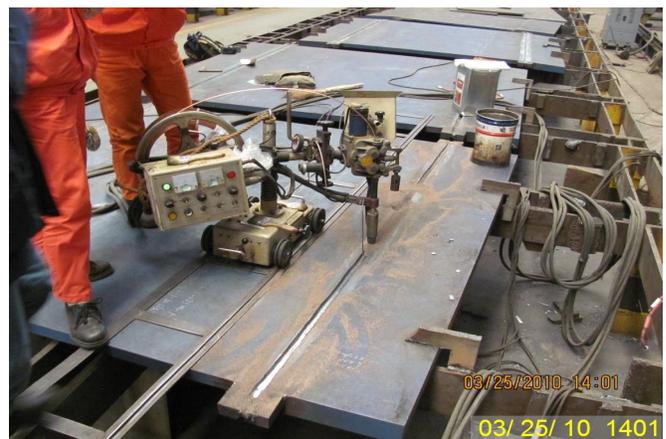
2. This QA inspector, Baskar Govindarajan, observed, ZPMC qualified welding personnel identified as 044550 perform SAW welding on, Strut Flange plate and weld joint identified as ND1-STSA4-6 B/M-1-4A. ZPMC CWI Identified as Mr. Yu Dong Ping. The welding parameters as measured using QC's calibrated instruments appeared to be in general compliance with WPS-B-T-4221-B-U3C-S-1. (Photo attached)
