**DEPARTMENT OF TRANSPORTATION**

Contract #: 04-0120F4Cty: SF/ALA Rte: 80 PM: 13.2/13.9File #: 69.28**WELDING INSPECTION REPORT****Resident Engineer:** Pursell, Gary**Address:** 333 Burma Road**City:** Oakland, CA 94607**Report No:** WIR-012912**Date Inspected:** 02-Mar-2010**Project Name:** SAS Superstructure**OSM Arrival Time:** 700**Prime Contractor:** American Bridge/Fluor Enterprises, a JV**OSM Departure Time:** 1900**Contractor:** Zhenhua Port Machinery Company, Ltd (ZPMC), Changxing Island **Location:** Shanghai, China**CWI Name:** Mr. You Qi Guo**CWI Present:** Yes No**Inspected CWI report:** Yes No N/A**Rod Oven in Use:** Yes No N/A**Electrode to specification:** Yes No N/A**Weld Procedures Followed:** Yes No N/A**Qualified Welders:** Yes No N/A**Verified Joint Fit-up:** Yes No N/A**Approved Drawings:** Yes No N/A**Approved WPS:** Yes No N/A**Delayed / Cancelled:** Yes No N/A**Bridge No:** 34-0006**Component:** Tower**Summary of Items Observed:**

**IN PROCESS INSPECTION:-****TOWER TRAIL ASSEMBLY AREA:-****EAST SHAFT LIFT 1:-**

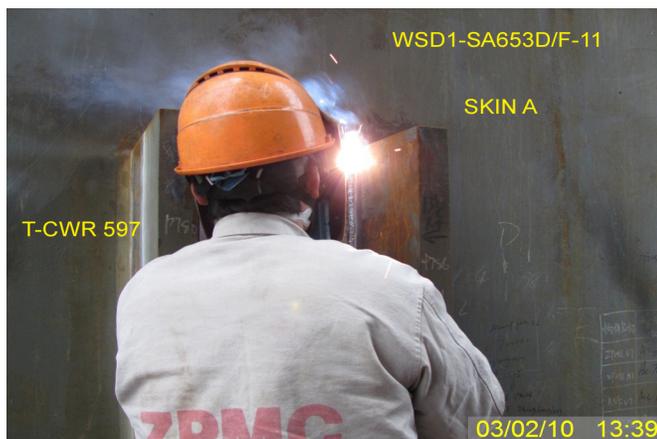
ZPMC performed Base metal repair of Interior Bearing Stiffener located on Skin A (WSD1-SA653D/F-11). The weld metal repair area is approximately 5mm depth and app.220mm length. The material is A 709M Grade 345 Non-SPCM. Welder is identified as 040690.ZPMC CWI is identified as Mr. Zhao Chen Sun. SMAW welding was performed against Critical Weld repair report T-CWR597. The welding variables recorded by QC appeared to comply with the WPS-345-SMAW-3G (3F)-Repair. Please see the attached picture below.
