Quality Assurance and Source Inspection

Contract #: 04-0120F4Cty: SF/ALA Rte: 80 PM: 13.2/13.9File #: 69.28**WELDING INSPECTION REPORT****Resident Engineer:** Pursell, Gary**Address:** 333 Burma Road**City:** Oakland, CA 94607**Report No:** WIR-012919**Date Inspected:** 11-Mar-2010**Project Name:** SAS Superstructure**OSM Arrival Time:** 700**Prime Contractor:** American Bridge/Fluor Enterprises, a JV**OSM Departure Time:** 1900**Contractor:** Zhenhua Port Machinery Company, Ltd (ZPMC), Changxing Island **Location:** Shanghai, China**CWI Name:** Mr. Zhao Chen Sun**CWI Present:** Yes No**Inspected CWI report:** Yes No N/A**Rod Oven in Use:** Yes No N/A**Electrode to specification:** Yes No N/A**Weld Procedures Followed:** Yes No N/A**Qualified Welders:** Yes No N/A**Verified Joint Fit-up:** Yes No N/A**Approved Drawings:** Yes No N/A**Approved WPS:** Yes No N/A**Delayed / Cancelled:** Yes No N/A**Bridge No:** 34-0006**Component:** Tower**Summary of Items Observed:**

WELDING INSPECTION REPORT

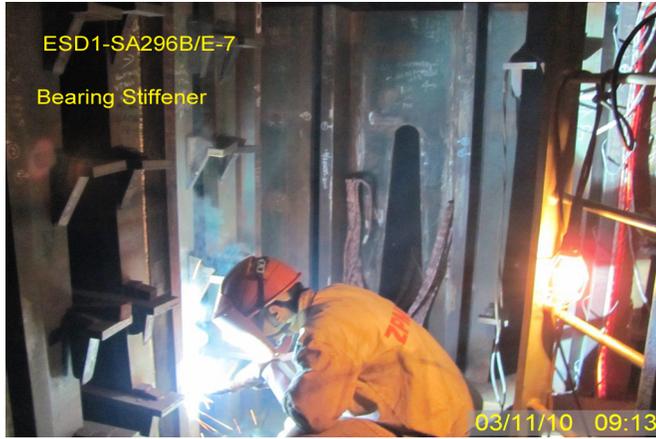
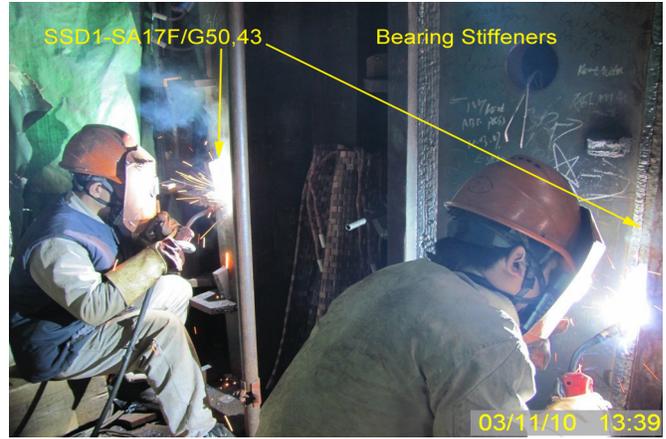
Unless otherwise noted, all work observed on this date appeared to generally comply with the applicable contract documents.
