DEPARTMENT OF TRANSPORTATION

Contract #: 04-0120F4Cty: SF/ALA Rte: 80 PM: 13.2/13.9File #: 1x.28**WELDING INSPECTION REPORT****Resident Engineer:** Pursell, Gary**Address:** 333 Burma Road**City:** Oakland, CA 94607**Report No:** WIR-012940**Date Inspected:** 06-Apr-2010**Project Name:** SAS Superstructure**OSM Arrival Time:** 1100**Prime Contractor:** American Bridge/Fluor Enterprises, a JV**OSM Departure Time:** 1930**Contractor:** American Bridge/Fluor Enterprises, a JV**Location:** Job Site

WELDING INSPECTION REPORT

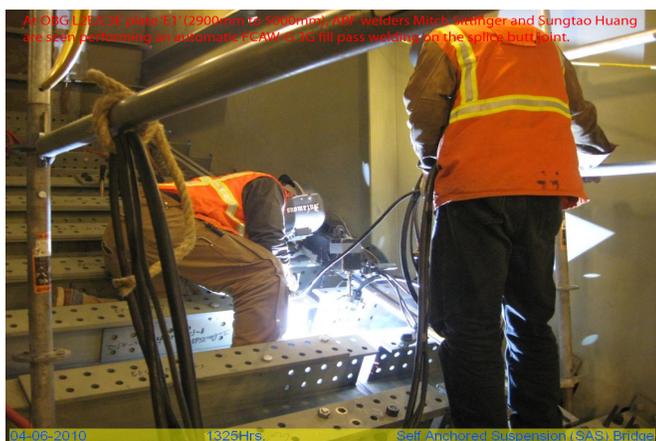
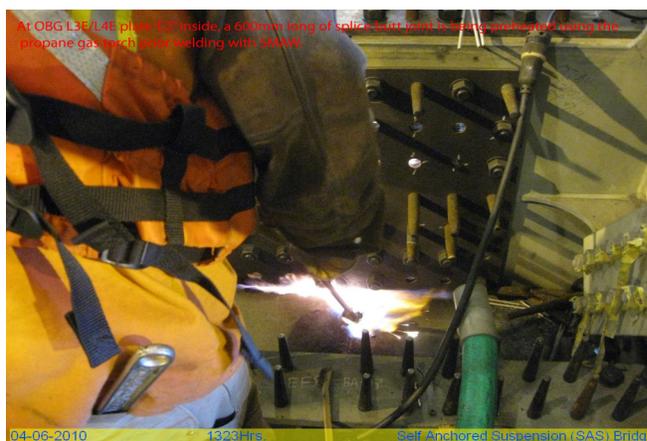
At OBG L2E/L3E plate 'E1' (2900 to 5000mm) inside, QA randomly observed ABF/JV qualified welder Sungtao, Huang ID #3794 and Mitch Sittinger ID #0315 perform CJP groove (splice) welding fill to cover pass. The welder was observed welding in the 3G (vertical) position utilizing an automatic dual shield Flux Cored Arc Welding (FCAW-G) with E71T-1M, 1/16" diameter wire electrode and implementing Caltrans approved Welding Procedure Specification (WPS) ABF-WPS-D15-3042A-1. The joint being welded has a single V-groove butt joint with backing bar. The splice joint was preheated and maintained to greater than 150 degree Fahrenheit using electric resistance heating bands prior welding. During welding, ABF Quality Control (QC) Bernie Docena was noted monitoring the welding parameters of the welder. QA performed parameter readings during welding with the following results; 230 amperes, 23.4 volts and 260mm per minute travel speed which were deemed acceptable to contract specifications. The ABF welders have completed welding the cover of the splice butt joint in this mentioned area and was noted visually inspected by ABF QC Bernie Docena.

After completing the weld just mentioned above, the welders moved to the top portion of the splice butt joint and manually welded around 200mm long of the weld joint where the Bug-o machine cannot reach. QA noted that the welders have used same process as also mentioned above.

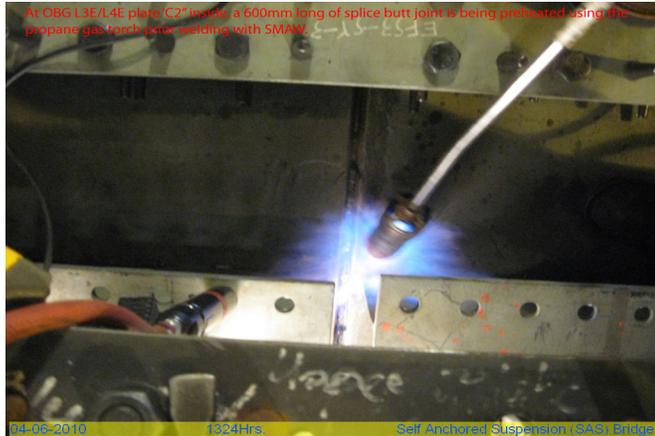
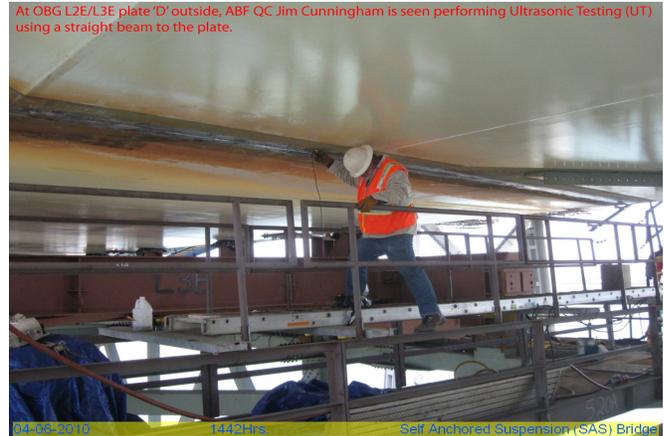
vertical (3G) position using Shielded Metal Arc Welding (SMAW). QA randomly observed the welder perform Complete Joint Penetration (CJP) groove (splice) welding root to fill pass. The welder was using E7018H4R, 1/8” diameter electrode and implementing Caltrans approved ABF-WPS-D15-1040B. Welding parameter measured during welding was 125 amperes which was deemed acceptable to contract requirements. During the shift, QA verified the qualification of the welder thru the welders list and was found out that he was not listed as one of the qualified welder for SMAW. QA asked the QC but said the welder took the welder’s test two weeks ago and passed the test. QC also mentioned that the welder’s qualification paper was already submitted to Caltrans.

At OBG L3E/L4E plate ‘E2’ inside (600mm long), another ABF welder James Zhen was noted welding in vertical (3G) position using Shielded Metal Arc Welding (SMAW). QA randomly observed the welder perform Complete Joint Penetration (CJP) groove (splice) welding root to fill pass. The welder was using E7018H4R, 1/8” diameter electrode and implementing Caltrans approved ABF-WPS-D15-1040B. Welding parameter measured during the SMAW welding was 130 amperes. After doing the root pass with some fill passes, QA noted the welder switched his welding process from SMAW to FCAW-G. During the FCAW-G welding, the welder was noted utilizing a manual dual shield Flux Cored Arc Welding (FCAW-G) with E71T-1M, 1/16” diameter wire electrode and implementing Caltrans approved Welding Procedure Specification (WPS) ABF-WPS-D15-3042A-1. Welding parameters noted during this process were 244 amperes and 22.8 voltages which were deemed acceptable to contract requirements.

Due to the awkward position of the splice butt joints (both at the bottom corner of plate ‘D’), the welders were having difficulty performing their task. At the end of the shift, both welders were still continuing welding and were not able to complete the welds.
