**DEPARTMENT OF TRANSPORTATION**

Contract #: 04-0120F4Cty: SF/ALA Rte: 80 PM: 13.2/13.9File #: 13.28**WELDING INSPECTION REPORT****Resident Engineer:** Pursell, Gary**Address:** 333 Burma Road**City:** Oakland, CA 94607**Report No:** WIR-012947**Date Inspected:** 06-Apr-2010**Project Name:** SAS Superstructure**OSM Arrival Time:** 1000**Prime Contractor:** American Bridge/Fluor Enterprises, a JV**OSM Departure Time:** 1830**Contractor:** Oregon Iron Works Clackamas, Or.**Location:** Clackamas, OR**CWI Name:** M. Gregson, J. Salazar**CWI Present:** Yes No**Inspected CWI report:** Yes No N/A**Rod Oven in Use:** Yes No N/A**Electrode to specification:** Yes No N/A**Weld Procedures Followed:** Yes No N/A**Qualified Welders:** Yes No N/A**Verified Joint Fit-up:** Yes No N/A**Approved Drawings:** Yes No N/A**Approved WPS:** Yes No N/A**Delayed / Cancelled:** Yes No N/A**Bridge No:** 34-0006**Component:** Hinge K Pipe Beams**Summary of Items Observed:**

# WELDING INSPECTION REPORT

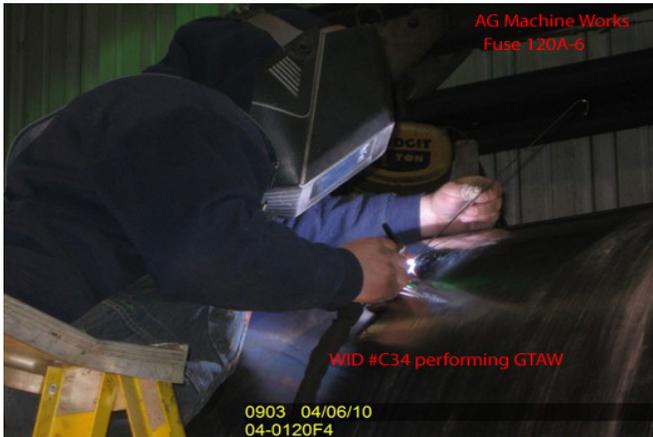
On this date, the QA Inspector arrived at AG Machine to observe OIW perform the weld repairs, on the finished overlay surface, on this Fuse 120A-6. The QA Inspector met with OIW QC Inspector Jose Salazar, OIW welder (WID# C34) Mark Craig and AG Machinist, Terry Schmale. QC Inspector Salazar explained that WID #C34 will be performing the Gas Tungsten Arc Welding (GTAW), on the previously excavated areas, on the finished overlay. QC Inspector Salazar explained that WID #C34 is currently qualified to perform these repairs and will be utilizing welding procedure specification (WPS 8022). The QA Inspector then witnessed WID #C34 performing the pre-heat required, utilizing a torch and then observed QC Inspector Salazar perform a pre-heat check, utilizing a digital thermometer, of approximately 200 degrees Fahrenheit, after the pre-heat was complete. The QA Inspector noted that 125 degrees Fahrenheit minimum was required, per WPS 8022. The QA Inspector then witnessed AG Machinist, Terry Schmale, rotating the fuse assembly in the horizontal lathe, to access the weld repair areas in the flat position. The QA Inspector then observed WID #C34 continue to perform the GTAW on the previously excavated repair areas and observed QC Inspector Jose Salazar, recording in-process welding parameters of 123 amps and 16 volts. The QA Inspector also verified these welding parameters. At approximately 1200, QC Inspector Salazar explained that the GTAW was complete and the QA Inspector noted that an OIW machinist had arrived at AG. QC Inspector Salazar explained that the OIW machinist will perform the grinding

flush of the repair areas. See attached picture below.
