**DEPARTMENT OF TRANSPORTATION**

Contract #: 04-0120F4Cty: SF/ALA Rte: 80 PM: 13.2/13.9File #: 13.28**WELDING INSPECTION REPORT****Resident Engineer:** Pursell, Gary**Address:** 333 Burma Road**City:** Oakland, CA 94607**Report No:** WIR-012975**Date Inspected:** 07-Apr-2010**Project Name:** SAS Superstructure**OSM Arrival Time:** 1000**Prime Contractor:** American Bridge/Fluor Enterprises, a JV**OSM Departure Time:** 1830**Contractor:** Oregon Iron Works Clackamas, Or.**Location:** Clackamas, OR**CWI Name:** M. Gregson, J. Salazar**CWI Present:** Yes No**Inspected CWI report:** Yes No N/A**Rod Oven in Use:** Yes No N/A**Electrode to specification:** Yes No N/A**Weld Procedures Followed:** Yes No N/A**Qualified Welders:** Yes No N/A**Verified Joint Fit-up:** Yes No N/A**Approved Drawings:** Yes No N/A**Approved WPS:** Yes No N/A**Delayed / Cancelled:** Yes No N/A**Bridge No:** 34-0006**Component:** Hinge K Pipe Beams**Summary of Items Observed:**

**Hinge-K Pipe Beam Assembly 120A-2:**

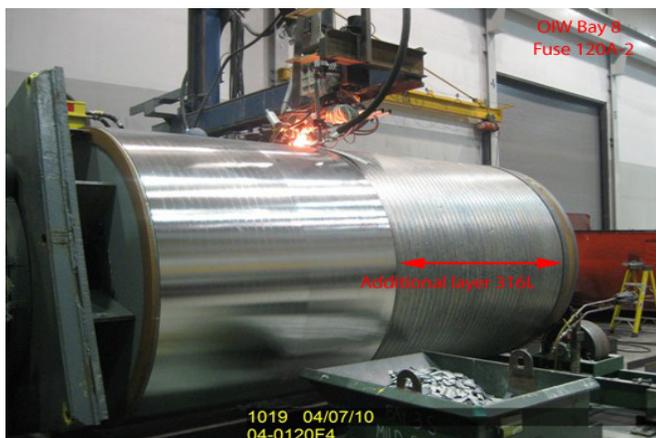
The QA Inspector witnessed WID #F17 (Igor Frolov), in-process of performing electro slag welding (ESW), on an additional overlay welding pass, utilizing Soudotape 316L stainless steel consumable strip. The QA Inspector noted that WID #F17 was currently qualified for this and was performing the ESW in the flat position. The QA Inspector noted that the ESW was now approximately 50 % complete.

The QA Inspector noted that Lead QC Inspector Mike Gregson was also present, during this shift, to monitor the ESW. QC Inspector Gregson explained that he had previously recorded in-process welding parameters of 1150 amps and 25.7 volts, with a minimum pre-heat temperature of 150 degrees Fahrenheit. QC Inspector Gregson explained that he had previously recorded a travel speed of 10.5 inches per minute (i.p.m.) and that Welding Procedure Specification (WPS) 7003 was being utilized. The QA Inspector randomly verified a pre-heat temperature of approximately 150 degrees Fahrenheit and verified welding parameters to be in compliance with AWS D1.5 and the applicable WPS 7003. See attached picture below.
